## Breakage of Automotive Spring Washer during Twist Test: A Metallurgical Analysis

### Abstract

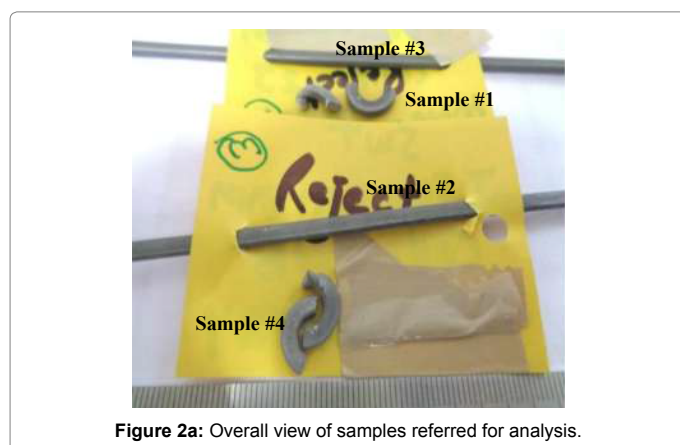
Failed samples were visually observed under macro dual zoom microscope Figure 2a. The nature of broken end indicated that the failure took place during twisting. The fracture surface of the broken spring washer revealed shiny granular appearance with chevron marks indicating brittle fracture (Figures 2b and 2c).

**Figure 2a:** Overall view of samples referred for analysis.

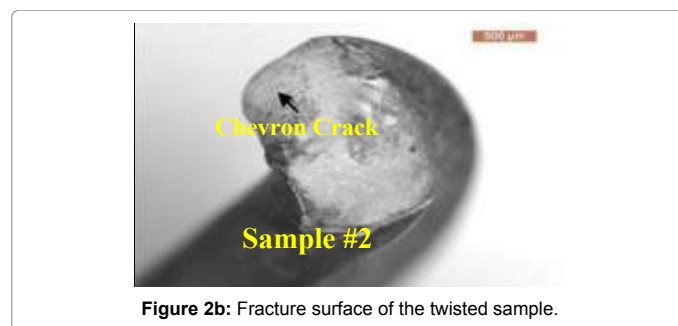
**Figure 2b:** Fracture surface of the twisted sample.

2. The fracture surface of the broken spring washer revealed shiny granular appearance with chevron marks indicating brittle fracture.

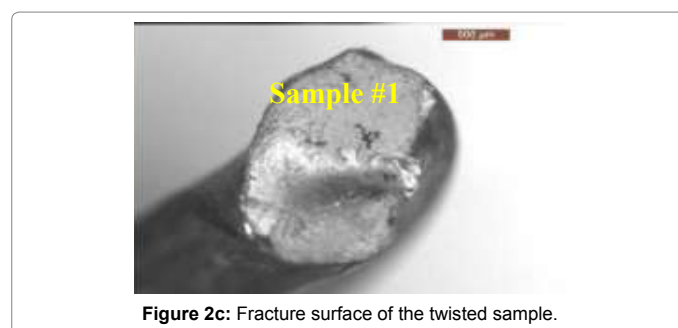
**Figure 2c:** Fracture surface of the twisted sample.

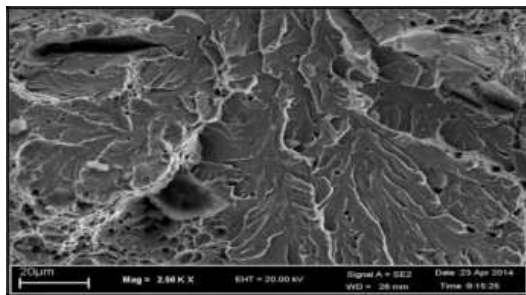
The fracture surface of the failed sample #1 was observed under Field Emission Gun Scanning Electron Microscopy (FEG-SEM) (Figure 3). Fractography of the fracture surface (sample #1) revealed cleavage nature of the fracture surface indicating brittle fracture.

**Figure 3:** Fractography analysis of sample #1 of the failed component.

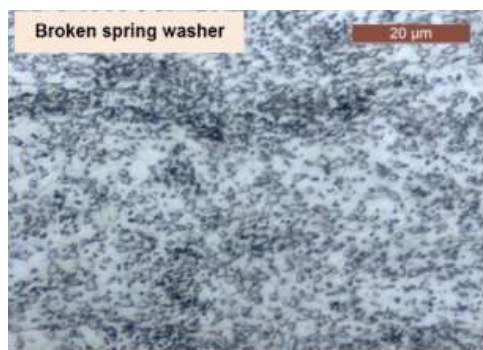
The failed sample was etched with 3% Nital solution. Etched microstructure revealed presence of spheroidized carbide in ferrite matrix. In both the failed spring washers, non/uniform spheroidisation was observed in Figures 4a and 4b without any carbide network.

**Figure 4a:** 3% Nital Etched microstructure of failed twisted Sample 1.

3. Microstructural analysis of both the failed spring washer sample shows non-uniform spherodisation structure. This indicates improper spherodise annealing cycle was followed.
4. Spheroidizing of high carbon steel is a method of prolonged heating at a temperature below the eutectoid temperature. By heating at this temperature pearlite, which is the lowest energy arrangement of steel, gets converted to ferrite and cementite. The graphite content of steel assumes a spheroidal shape after spheroidizing and after prolonged heating the pearlite layers are broken down and spherical lumps of cementite, or spheroidite, are formed [5-7].
5. Due to the abnormality in the heat treatment process of the flat wire samples non-uniform spherodisation structure was formed which resulted in high hardness of the sample. Due to the high hardness, the washer samples failed during twist test.

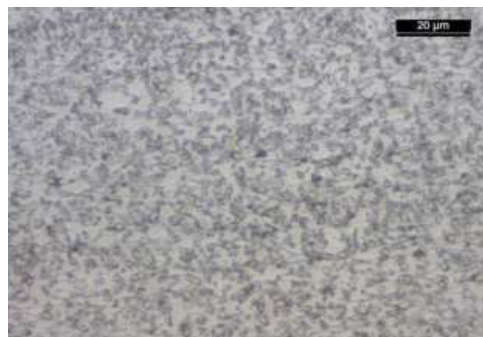
**Figure 4b:** 3% Nital Etched microstructure of failed twisted Sample 2.

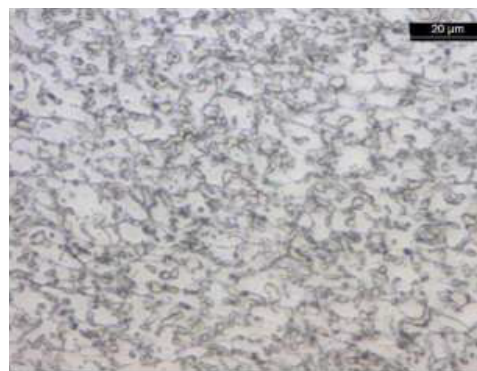
The flat wire samples (3 and 4) of the failed lots were subjected to heat treatment to find out the effect of the heat treatment cycle. First the component was heated above austenizing temperature at around 850°C, followed by cooling at a temperature below the eutectoid temperature 700-710°C. It was then hold for a prolonged period (22-25 Hours) and furnace cooling was done at a very slow rate with appropriate soaking time (Figure 5a). After heat treatment distribution of spheroidized carbide was found more uniform in spring washer samples after heat treatment than that of rejected samples (Figures 5b and 5c).

**Figure 5b:** 3% Nital Etched microstructure of flat failed samples before heat treatment.

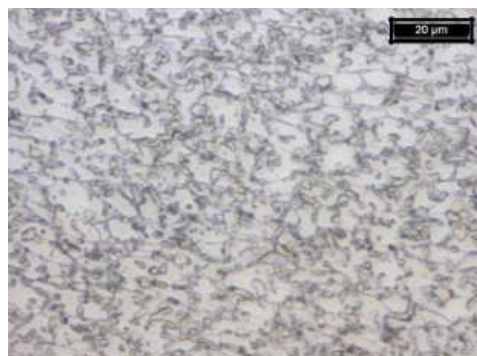
**Figure 5c:** 3% Nital Etched microstructure of flat failed samples after heat treatment.

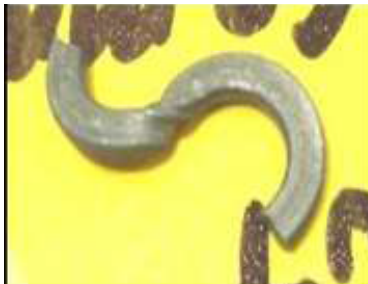
Twisting operation is done as per IS 6755 specifications [4]. In case of twist test a portion of the spring washer is gripped in vice jaws and then equal portion is gripped in wrench jaws as shown in Figure 6a. The wrench is then rotated in a direction that increases the free height of the spring washer till the washer is twisted through an angle of 90°. It is slowly and evenly bent (not jerkily) taking precaution to prevent injuries through fly splitters Figures 6b and 6c. In case of “after heat treatment” sample no fracture was observed during the twist test (Table 3).

**Figure 6b:** Overall view of sample before heat treatment.

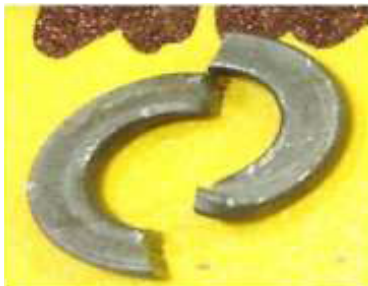
**Figure 6c:** Overall view of sample after heat treatment.
