# Do Modern Femoral Stems Break?

Kevin McSorley\*, John Galbraith, Derek Bennett and Rehan Gul

Department of Orthopaedics, Connolly Hospital Blanchardstown, Blanchardstown, Ireland

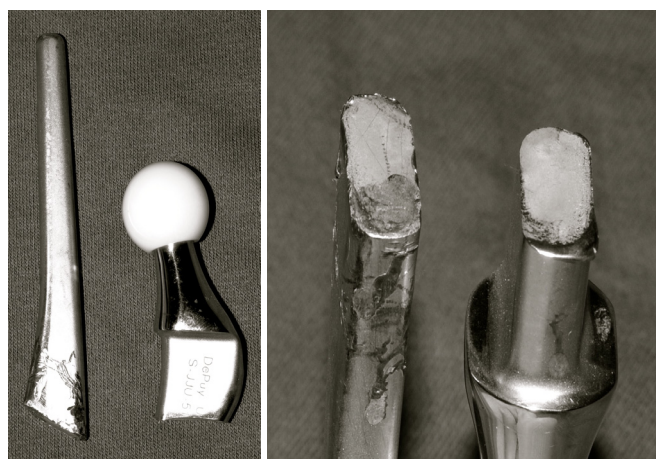
We present the case of a 43-year-old female with a background history of left Total Hip Replacement who presented to the clinic with progressively worsening left hip and groin pain over the previous 2 years with sudden deterioration in her mobility over one week. On examination she had a significant pain in the left hip and groin on all hip movements associated with tenderness over the left greater trochanter. An Anterior-Posterior (AP) pelvic radiograph identified an oblique fracture through the proximal third of her Charnley Modular femoral stem.

Her primary Total Hip Replacement had been carried out 15 years prior to this presentation for avascular necrosis of the femoral head secondary to Slipped Capital Femoral Epiphysis. A Size 1 Charnley Modular stem was cemented in with a 22.225 mm 9/10+0 Ceramax Head. Her post-op course was uneventful and she was discharged home in a timely manor. She had been pain free in the left hip at all follow-up appointments up to 2 years prior to this presentation. All previous radiographs demonstrated a well positioned prosthesis with no evidence of fracture or loosening. No specific remarks were made about the cement mantle (Figures 1a and 1b).

Figure 1A-1B: Views of the fractured Charnley Stem after removal.

On diagnosis of the broken stem, she was scheduled for a single stage revision. This was carried out through an anterolateral approach with removal of the proximal fragment of the femoral stem. The distal

fragment of the femoral stem was well fixed in cement and was removed using a burr. The remaining bone stock was poor and a new Exeter V40 femoral stem with a 44 mm offset was cemented in place with a 28 mm standard Alumina ceramic femoral head. Eccentric wear was noted in the original polyethylene liner, so this was replaced 52 mm Duraloc Enduron Liner. Post-operatively she was mobilised with full weightbearing as tolerated and discharged for rehabilitation.

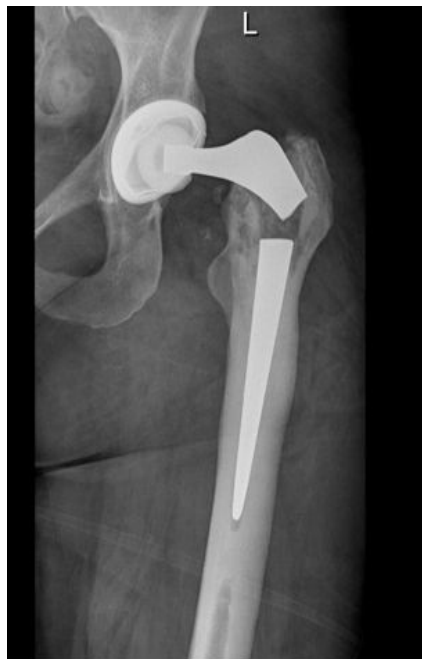
The second case involves a 40-year-old female with a background history of left Total Hip Replacement and increased BMI who presented with sudden onset of severe pain in her left hip. On examination she had tenderness over the left hip and significant decrease in range of motion, both active and passive. An AP pelvic radiograph identified a transverse fracture through the proximal third of her Exeter femoral stem as the source of her symptoms.

Her primary Total Hip Replacement had been carried out 5.5 years prior to this presentation following a subcapital neck of femur fracture. This was carried out through a posterior approach with the insertion of a size zero Exeter V40 femoral stem with a 37.5 mm offset and 28 mm+4 mm alumina femoral head along with a 50 mm Duraloc acetabular cup and Duraloc Enduron Liner. Her post-op course had been uneventful and at her last follow-up, 3 years previously, she had not reported any pain and had excellent function. Stem position at this review was satisfactory with no evidence of loosening (Figure 2).

**Figure 2:** Anterior-posterior radiograph showing the broken Exeter femoral stem.

A single stage revision was carried out through an anterolateral approach with an uncomplicated removal of the proximal fragment of the femoral stem. The proximal cement mantle was loose and easily removed with a burr. A lateral cortical window allowed the distal femoral stem fragment to be pushed proximally and removed. A new size zero Exeter V40 femoral stem with a 37.5 mm offset was cemented in place with a 28 mm+4 mm femoral head. Post-operatively she was mobilised with full weight-bearing and discharged for rehabilitation on the third day.
