Metallurgical Investigation of Tie Rod used for lifting Ferro-Alloy during Steel Making: A Safety Issues

Souvik Das*, Kaushal Kishore and Manashi Adhikary

Tata Steel Limited, Jamshedpur, India

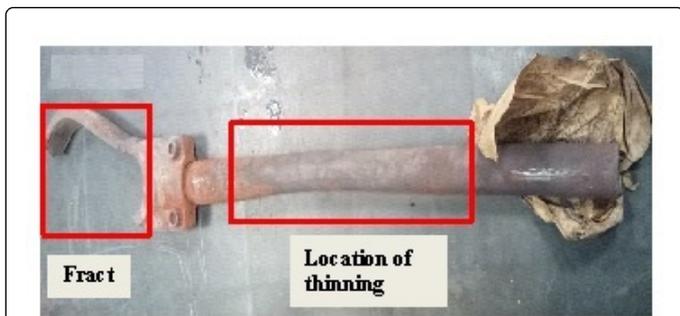
Failure occurred after approximately 1 month of service life which is much below is its expected service life of at least 6 months. Tie rod thinned down substantially as shown in the Figure 1. Bracket also suffered substantial deformation prior to fracture.

Figure. 1a shows the overall view of the failed tie rod and the bracket.

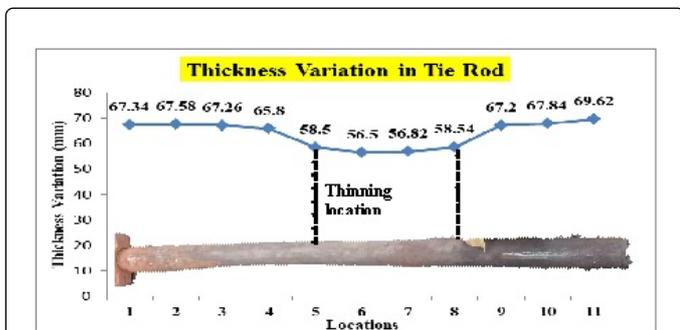
Measurement of thickness was carried out along its length. It revealed a minimum thickness of 56.5 mm at the location of thinning. At locations away from thinning, thickness was measured to be 69.62 mm. The length of the tie rod is around 1880 mm and it get increased up-to 2145 i.e 12.35% elongation was observed in the failed region. The original diameter was 65 mm and diameter at the necked region was 56.5 mm thus there is around 13% reduction in diameter. One sample was taken from the region where no necking was observed and no thinning was observed at that location. Tie rods are often exposed to flame of the LD vessel along with the tensile stress. This situation is sufficient to cause creep mode of deformation. However, this needs to be validated with microstructural analysis. Figure 2 (a) shows the overall view of the failed tie rod along its length.

Figure. 1b: Visual images of the failed tie rod

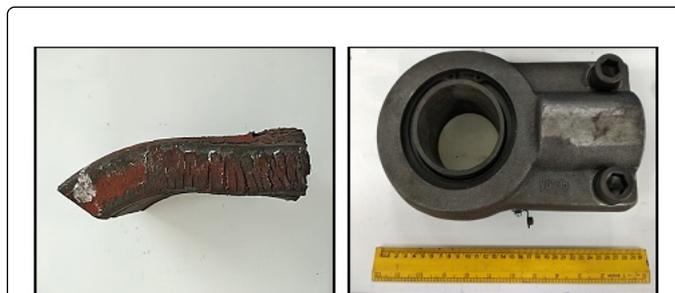
Failed bracket is shown in Figure 1(c). Thermal cracks are observed. New bracket is shown in Figure 1 (d). It was referred for non-destructive analysis. Comparing this with the failed one suggests the enormous amount of deformation that the bracket underwent prior to the failure.

Figure.1: Visual images of the (c) failed bracket, (d) new bracket

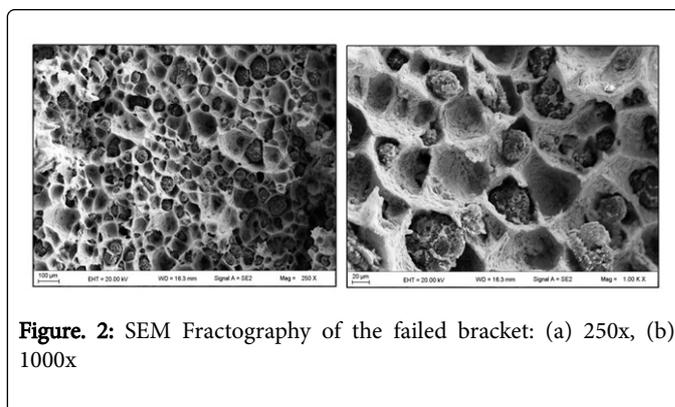
Fracture surface of the bracket showed dimples as shown in Figures 2a and 2b. These dimples have predominantly graphite nodule within them. It suggests ductile mode of failure which is rare for cast iron and it is due to exposure to high temperature for prolonged duration that activated sufficient slip systems to cause plastic deformation before fracture.

Figure. 2: SEM Fractography of the failed bracket: (a) 250x, (b) 1000x

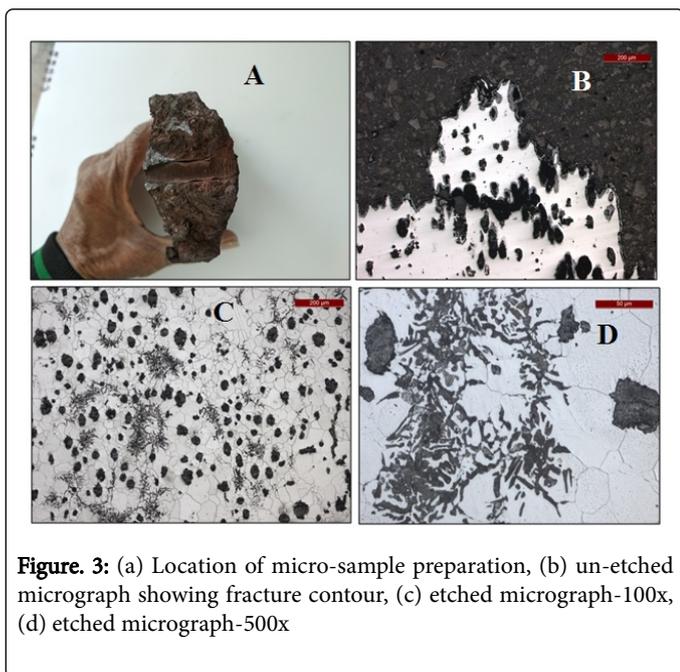
Failed Bracket:

Micrograph of the failed bracket showed substantial bursting of the graphite nodules (Figures 3a-3d). These are typically observed when SG iron is subjected to very high temperature for prolonged time. It is evident that such deterioration occurred in the failed bracket during service as graphite nodules were observed without any bursting in unused / new bracket (Figure 3e and 3f).

Figure 3: (a) Location of micro-sample preparation, (b) un-etched micrograph showing fracture contour, (c) etched micrograph-100x, (d) etched micrograph-500x

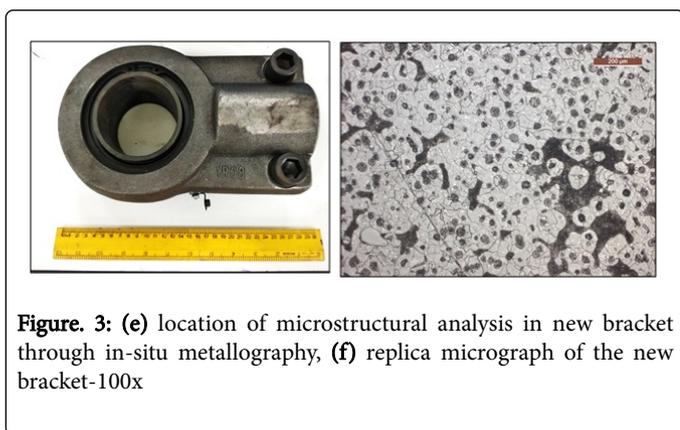
New Bracket:

Figure 3: (e) location of microstructural analysis in new bracket through in-situ metallography, (f) replica micrograph of the new bracket-100x

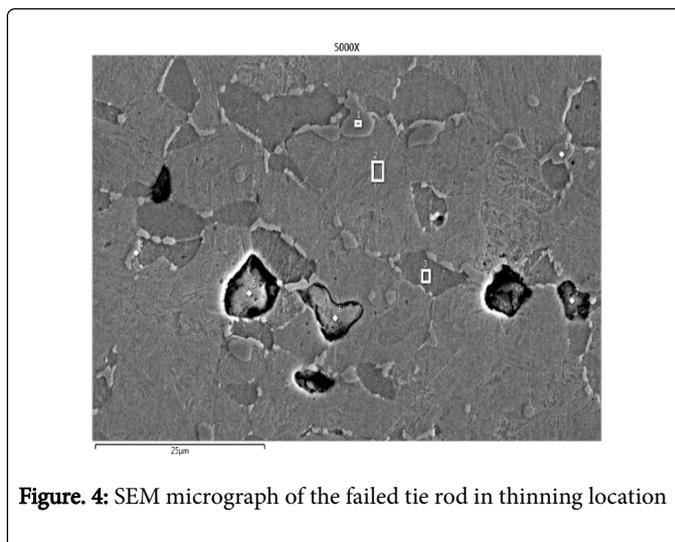
EDS analysis was carried out on the globular particles found in microstructure in the necked region. The EDS analysis in the globular particles showed iron carbides at grain boundary and along that at 5000 X magnification few creep voids were observed at grain boundary triple points as shown in Figure 4 and Table 2. Hardness profile was measured along the length of the tie rod (Table 3). An increase in hardness was observed near thinned region. This is probably due to

microstructural deterioration due to precipitation of carbides at elevated temperature.

Figure 4: SEM micrograph of the failed tie rod in thinning location

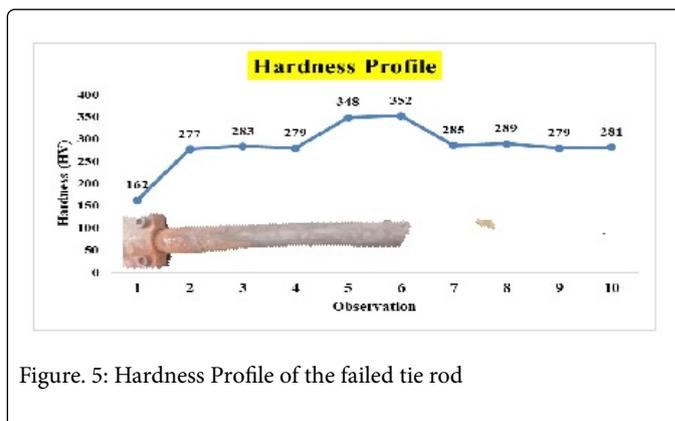
Hardness profile was measured along the length of the tie rod. An increase in hardness was observed near thinned region. This is probably due to microstructural deterioration due to precipitation of carbides at elevated temperature.

Figure 5: Hardness Profile of the failed tie rod

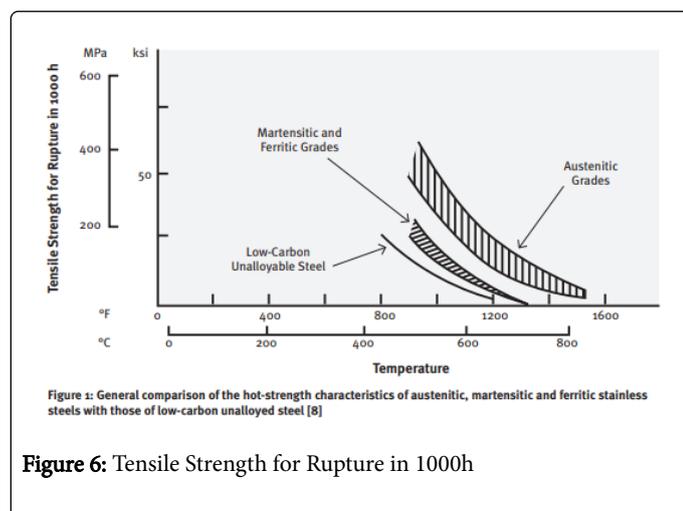
and found to be 3 orders lower than general creep resistant steel [6,7]. For better creep performance as shown in the Figure 6, certain austenitic grades have substantially higher tensile strength for rupture in 1000 h at all temperatures between 800°C-1200°C compared to ferritic or martensitic grades (existing). Thus, there exists a scope of improved creep resistant material.

For tie rod purpose, grades like GX30CrSi7 and GX35NiCrSi2521 can be used.
