Cement Burn of the Skin During Total Hip Arthroplasty: A Case Series

Murayama K*, Oinuma K and Tamaki T

Department of Orthopaedic Surgery, Joint Reconstruction Centre, Funabashi Orthopaedic Hospital, Hazama, Chiba, Japan

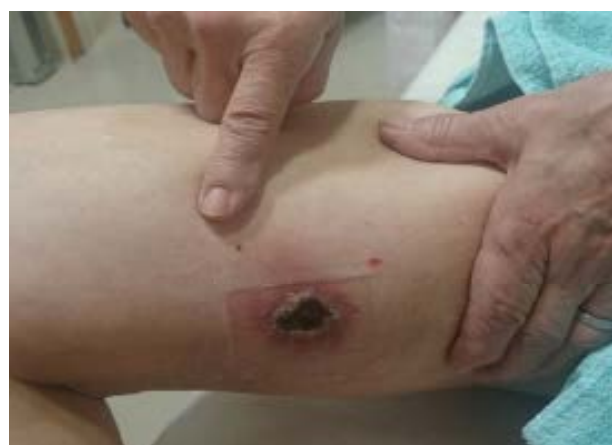
Figure 2: Cement burn of the skin with ulceration and partial scabbing on the medial side of the femur on postoperative 6 weeks.

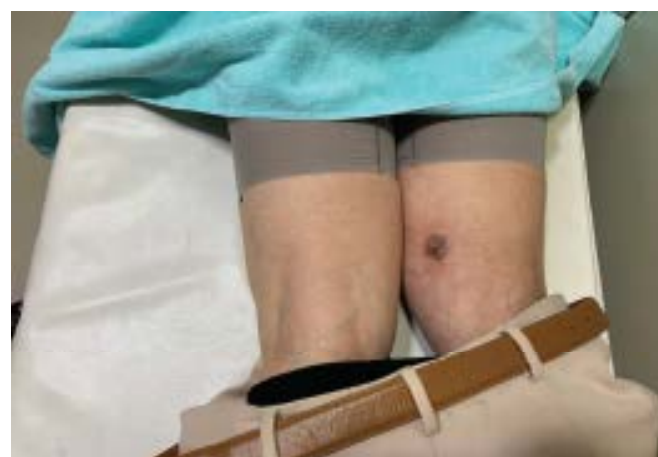
Figure 3: Cement burn of the skin was fully crusted after 4 months of surgery.

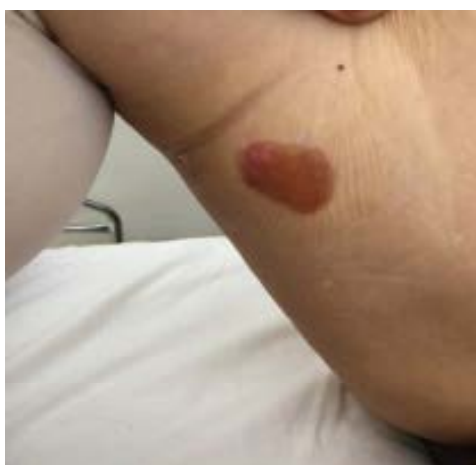
Figure 1: Cement burn of the skin on the medial side of the femur on postoperative day 1. A bursa measuring 2×2 cm was observed after the bandage was removed.

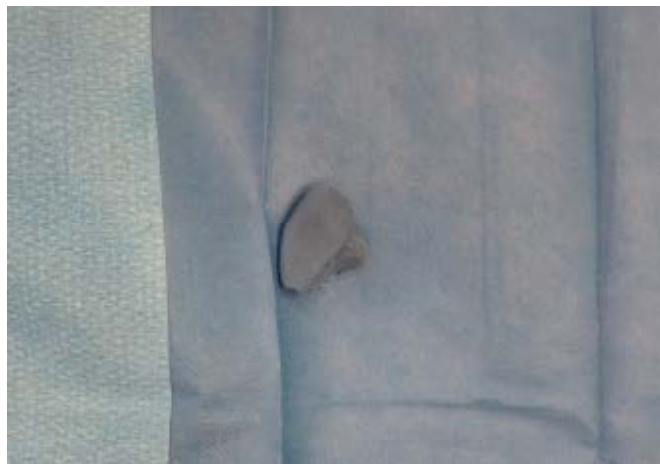
Figure 4: Excessive bone cement during THA procedure. Bone cement and drape are similar in color.

The excessive bone cement, attached to the areas of the compressed skin (heel, lateral malleolus of ankle, and calf), could be one of the reasons for delayed discovery. Similar colours of the bandage and bone cement could also delay the discovery of such skin burns. Excessive bone cement should be promptly discarded to prevent burn complications on the skin surface.
