Fracture of Peripheral Line during Removal in an Orthopedic Case

Kinzang Dorji*

Samtse College of Education, Royal University of Bhutan, Thimphu, Bhutan

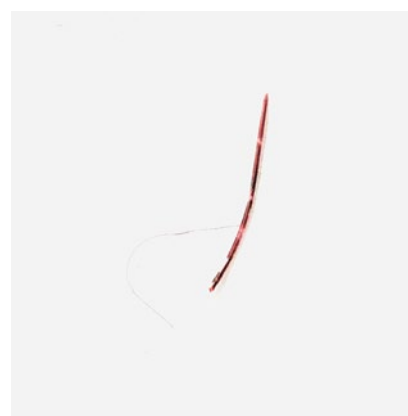
After completion of 72 hours postoperative period, IV line was ordered for removal. During the procedure of removal by the nurse on duty, only the proximal part of IV cannula came out, the distal part was still in the vein.

part in the vein. USG- revealed a fractured cannula in the cephalic vein over the cubital fossa. The patient party was made to understand the importance of immediate retrieval of the broken fragment, and explained its associated complication if delayed.

Figure 1. Showing the broken fragment of cannula removed which was kinked.

Under the sterile condition, local anesthesia was given, a longitudinal incision was made over the palpable site of skin and the cephalic vein was isolated. Venotomy was done and gentle retrieval of the cannula was done. Wound was sutured with 4.0 nylon and postoperative period was uneventful (Figures 1 and 2).

When performed properly, intravenous line insertion is a safe procedure [2]. There are several contributing factors which may lead to the fracture of IV cannula:

- 1) Improper technique of IV line insertion contrary to its protocol
- 2) Prolonged duration of IV line in situ
- 3) Poor IV line care by both the patient and health worker
- 4) Inferior quality of IV cannula
- 5) IV line over the joints where it is constantly kinked with range of motion

In an orthopedic setting patients need early passive and active range of motion. Therefore, IV line over joints or near to joints invariably fails due to constant pressure caused by motion. When broken, it necessitates immediate removal because of the complications associated with it. A paper by Dr Lundgren and the team in their study over the care and handling of peripheral IV line of 60 cases concluded that 52% of cases were unsatisfactory to very unsatisfactory [4].

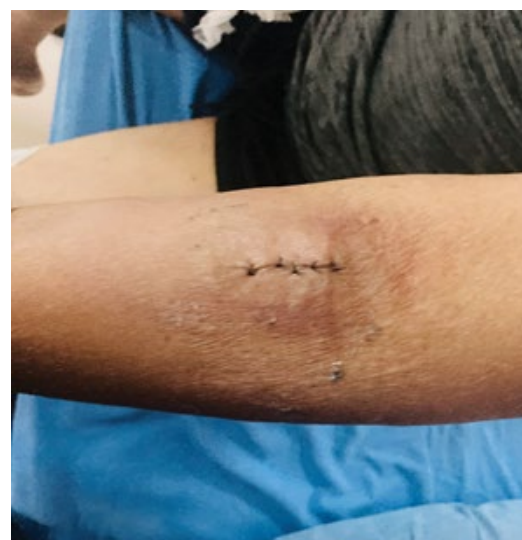
Figure 2. Demonstrating uneventful healing of incision site.
