Impacts of Furrow Irrigation on Shesher and Welala Natural Reservoirs of Lake Tana Sub Basin, Ethiopia

The survey was conducted from March 2012 to March 2013 based on field observations and samples. Shesher is natural reservoir of Lake Tana found at coordinates of 0350300 and 1322162 UTM and at altitudes 1805 a.s.l. Welala natural reservoir is found at UTM coordinates of 0348348 and 1326081 with altitude of 1804 a.s.l. The area of Shesher and Welala was estimated about 500 ha and 110 ha respectively, which are impounded by open water for extended period of a year and both with maximum depth of 3 m during rainy season. Both reservoirs filled their capacity during the rainy season through the inflow river of Ribb and the surrounding flood plain. But during pick dry season of March, 2012 and March 2013 the survey showed unexpected, amazing and sudden death of a home for many biodiversity that both Shesher and Welala natural reservoirs dried up totally. Birds fetch their food from remnants small shrink wet mud spot and it is not uncommon to see remnant dead fishes eaten by birds. This is due to several and unlimited human encroachments mainly for crop cultivation, without any rules an

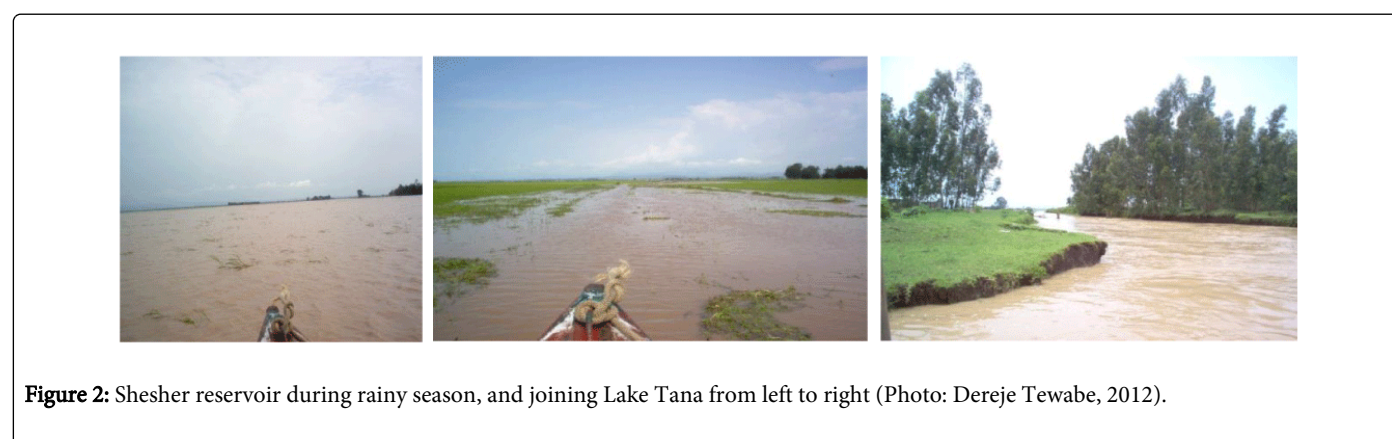
Shesher is natural reservoir of Lake Tana found at coordinates of 0350300 and 1322162 UTM and at altitudes 1805 a.s.l, which filled its capacity during the rainy season through the inflow river of Rib and the surrounding flood plain. This reservoir is estimated with an area of 500 hectares filled with water and free from vegetation cover due to its high relative depth that estimated of maximum depth 3m during the pick rainy season (Figure 2). According to [6], the surface area of Shesher shirked by 91% to 136 hectares from what it was 1557 hectares in 1987. The whole boundary of this reservoir was cultivated by the inhabitants with rice production at all water logged areas during the rainy seasons. Most of their livestock are transferred to the neighboring upland community settlements until the harsh flooding condition passed away. Few numbers of cattle mostly oxen and milked cows left to the surrounding fed by collecting weeds from their rice farm. Fishing was the most farming practice during the flooded periods, using predominantly of spears followed by beach seines during post rainy seasons. *Clarias gariepinus* is the most abundant fish species because its reproductive biology is favored by this natural reservoir of Shesher wetlands.

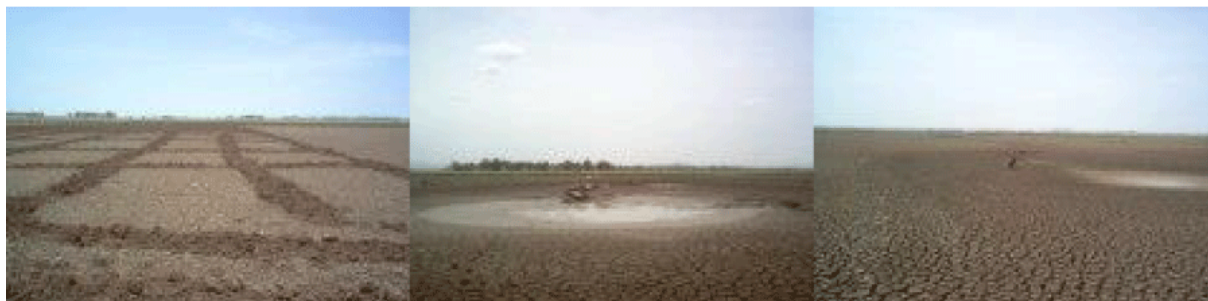
During pick dry season of March, 2012 the survey showed unexpected, amazing and sudden death of a home for many biodiversity and life full of Shesher natural resource dried up totally and birds fetch their food from remnants small shrieked wet mud spot (Figure 3). This happened due to several and unlimited human encroachments for different activities mainly for crop cultivation, with

Figure 3: Total dried up of Shesher reservoir with shrieked mud aggregated by birds at the center.

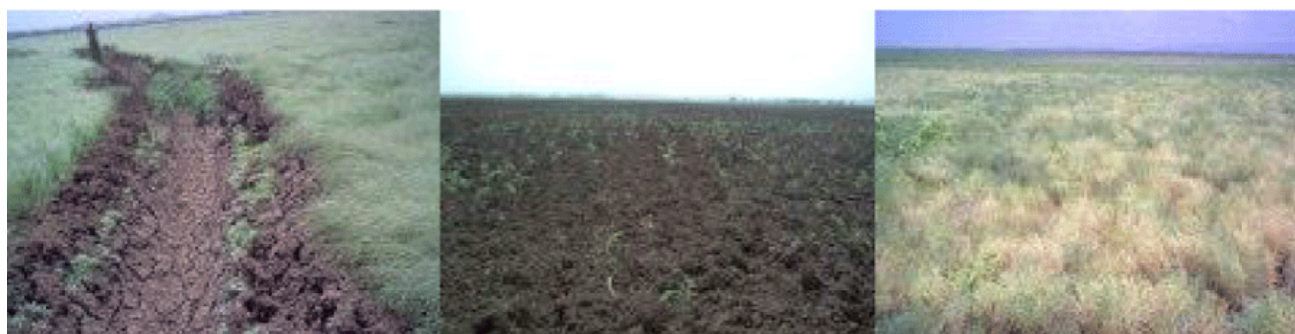
out any rules and regulations. Major crops cultivated by drained Sheshers water using gravitational force were *Eragrostis teff*, Cheak pea, Lentils and Safflower (Figure 4). It seems the community lacks knowledge and awareness about Shesher reservoir wetland of sustainable use other than exploiting beyond its maximum limit. During the dry seasons the inhabitants could not be able found

Figure 4: Major crops cultivated by draining water through furrow irrigation system from Shesher reservoir of Lake Tana wetland.

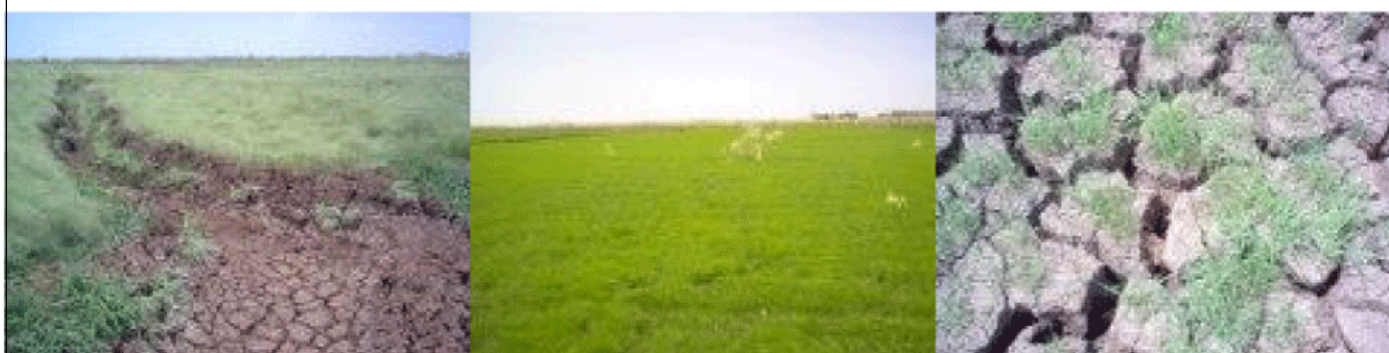
Un studied water use that is extensive use of irrigation to all directions of the reservoir causes shortage or even loss of whole available water which leads to wilt and dried of crop prior its ripening

periods, there has been a lot of clues such as cracking of soil at early stage of *Eragrostis teff* and its color also indicates its future negative fate that might end up with non ripe seeds (Figure 5).

Figure 5: Lack of irrigable water that shows cracked soil and poor plant color of *Eragrostis teff* that might lead to wilt and death of a plant prior to ripe.

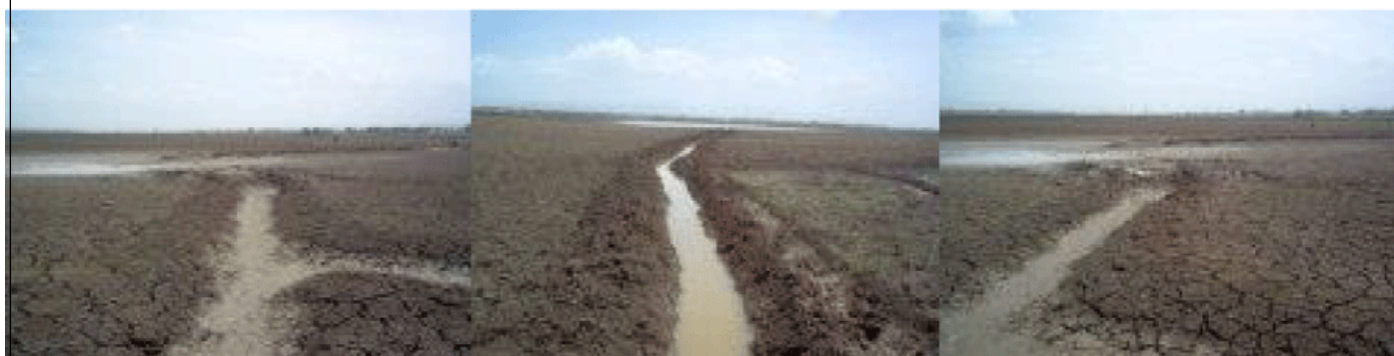
Such type of irrigation system in Shesher reservoir could not be recommended practice because it is not well studied and high pressure was imposed from four kebele inhabitants of its surrounding without calculating its carrying capacity, it drained until the water lost from the area by making furrows even followed its small shrinkage (Figure 6).

Figure 6: Uncontrolled drainage of Shesher reservoir for irrigation purpose until it totally dried up from the area.

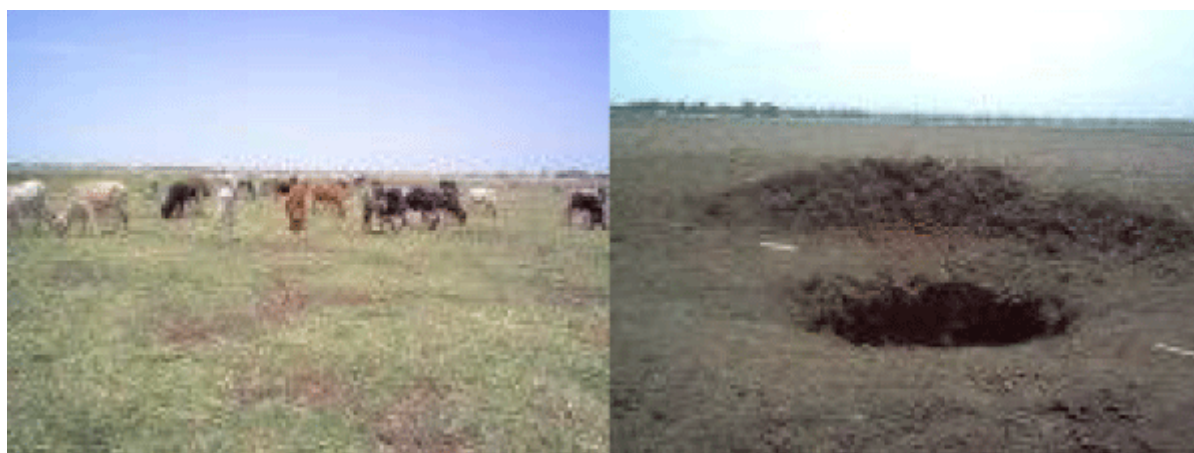
Water could not be found even for drinking of their animals and for themselves, as a result they started digging of the ground to fetch water for themselves and their animals (Figure 7).

Figure 7: Digging ground water (Well) at the center of Shesher reservoir for their animals after complete dried up of the reservoir.

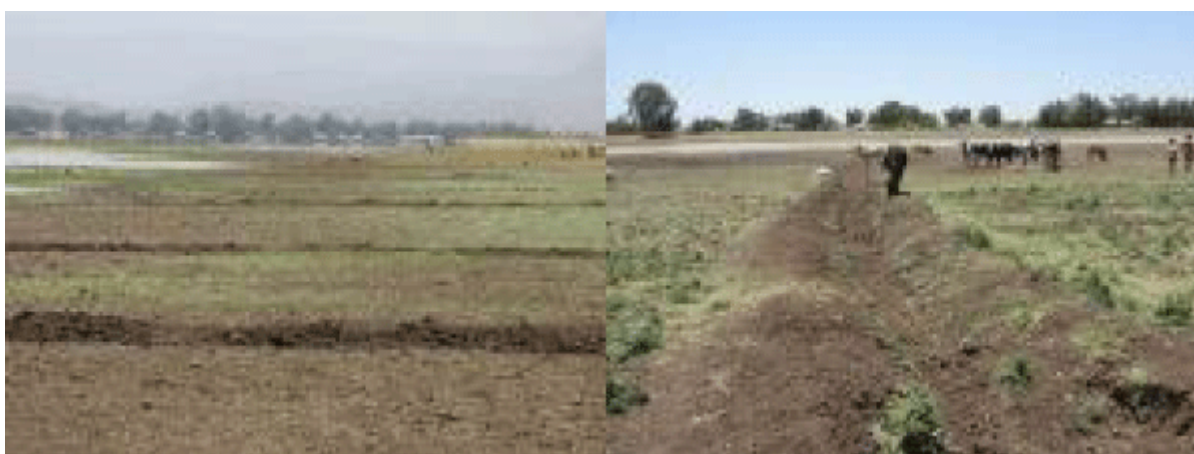
Figure 8: Furrows of Welala reservoir with 50 m intervals at both sides of farm lands to irrigate their crops.

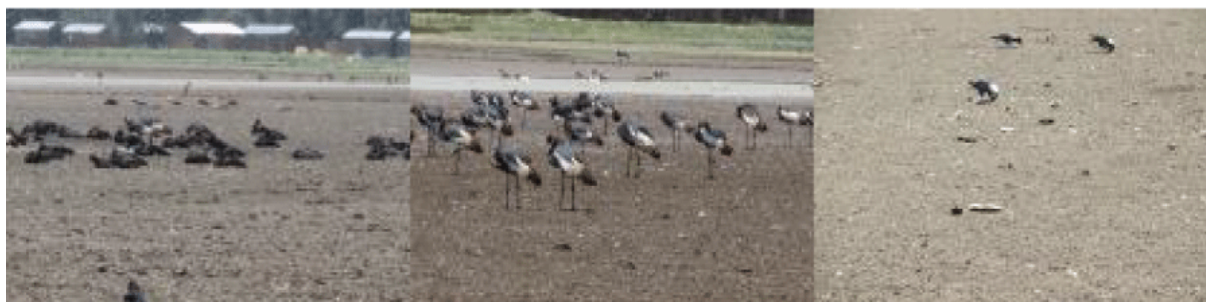
Especially fishes and birds are seriously affected during the pick dry seasons of the area and it is not uncommon to see remnant dead fishes eaten by birds (Figure 9). If Welala wetland could be protected from several imposed activities from the inhabitants it might be properly exploited by designing appropriate interventions for instance it can serve for fisheries and ecotourism activities (Figure 10).

Figure 9: Highly populated birds and remnant dead fishes eaten by birds in the highly shrunked and almost dried Welala wetlands.

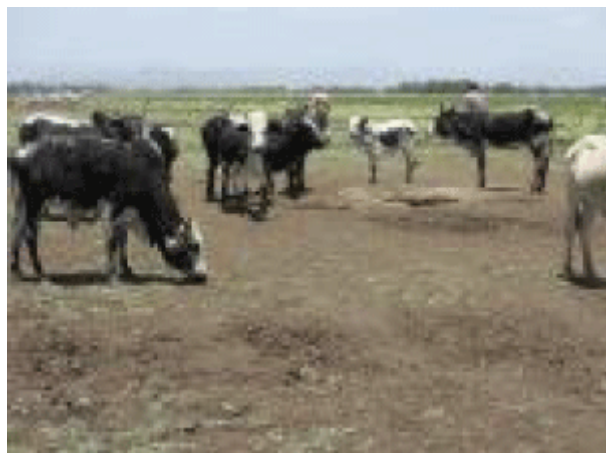
The only area considered for communal grazing land by the community was the open water of Welala during its drainage period assuming the area becomes devoid of water. But there has not been observed any foraging types, it was free from vegetation cover and livestock of the surrounding waiting for watering systems from underground water and feeds from supplements probably of crop residues (Figure 11). The area is known for breeds of Fogera with their high performance traits.

Figure 11: A paradox, cattle production system awaiting for watering from the well and supplemented feed stuffs from crop residues.
