# *In Situ* Investigation of the Biodeteriorative Microorganisms Lived on Stone Surfaces of the Sumela Monastery (Trabzon, Turkey)

*In situ* investigation of the biodeteriorative microorganisms lived on the Sumela monastery stones were identified using Microbial Identification System (MIS) and SEM-EDS combined system energy dispersive spectrometric investigations. The results showed that wide variety micro/macro-organisms dwell on stones of the Sumela Monastery. Total 24 species and 10 genres were determined on the deteriorated stone surfaces by microbial identification studies. The settled way of these organisms on stone surface were illustrated by SEM images. EDS analyses show that the major elements constituting the stones of the Sumela Monastery are silicon, aluminum, calcium, potassium, titanium, magnesium, zinc, sulfur, iron, sodium and niobium. Some of these elements could provide energy resources for the microorganisms by dissolving stone-surfaces of the Monastery. However, the biodeteriorative effect of micro/macro-organisms is more significant on stones of the Sumela Monastery, we see that the man is the most destructive agents on the historical building among all of the

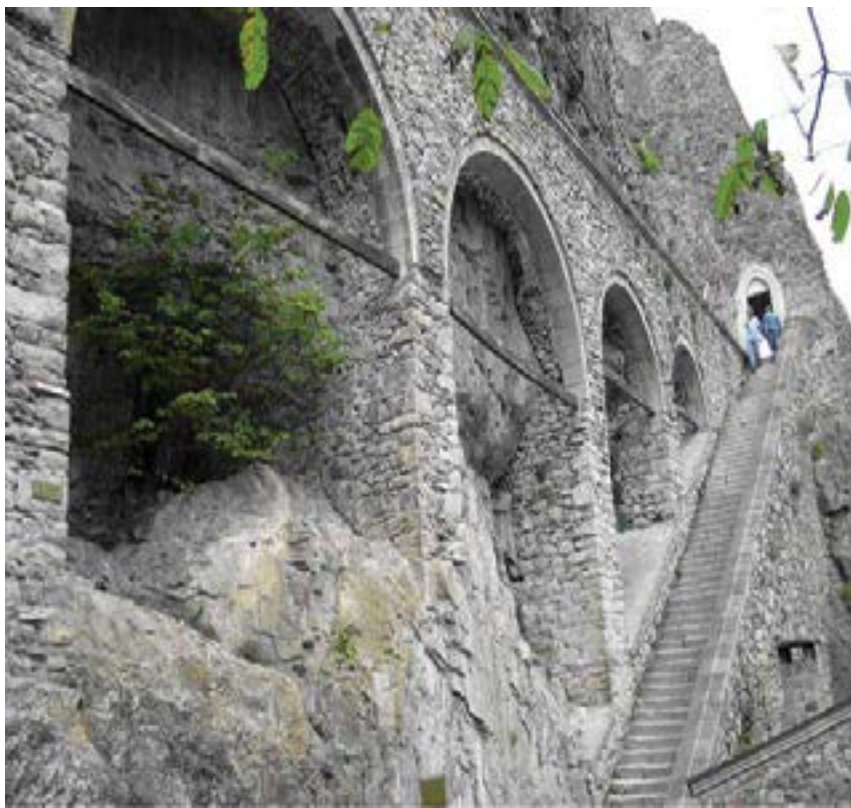
**Figure 2:** The access to the monastery.

As seen in Figure 2, roots of weed and trees are destroying the monuments [23]. Since the climatic conditions become temperate and rainy, the weed, trees and microbial consortia is abundant on the stone surfaces of the Monastery and the environment. Typical examples are shown in Figures 6-9, 11 and 13. In the Sumela Monastery, the colors of stone surface biofilm are frequently changed to brown, caramel, sorrel, white and sometimes black (Figures 8-11 and 13). This is due to the growth of algae and lichens. Growing algae and lichens have caused the aesthetically detrimental effect due to their pigments. The microbial discoloration of stone and rock surfaces has to be considered as a primary biogeophysical impact on the mineral surfaces [4,15].

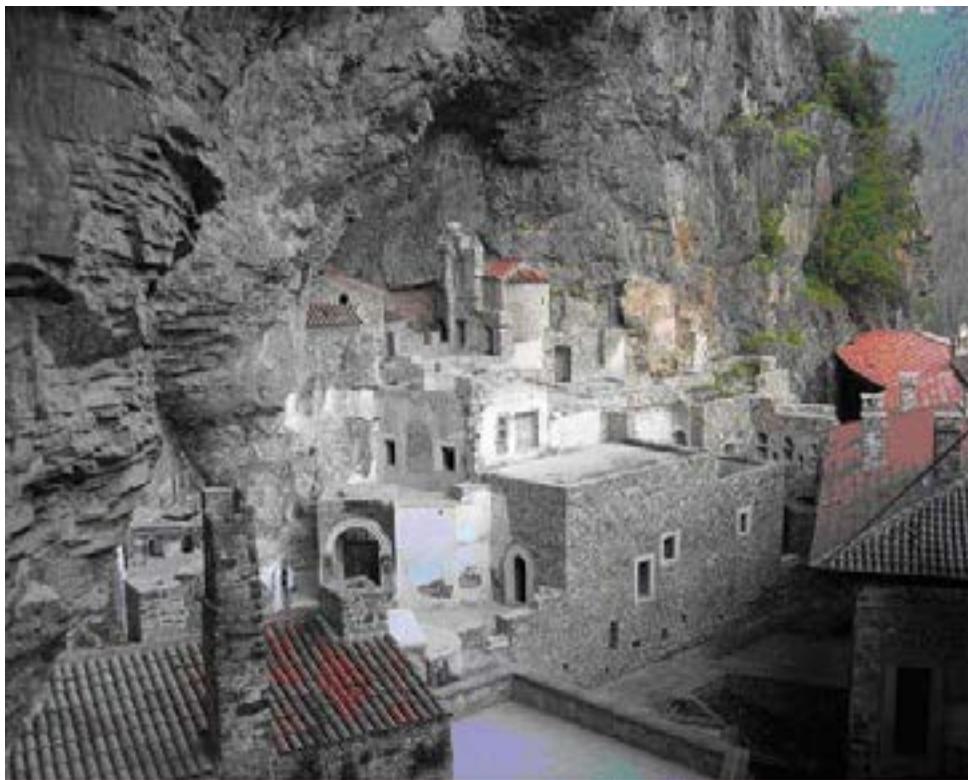
**Figure 3:** The monastery rooms in the cave.

The monastery complex had 5 floors and a total of 72 rooms (Figure 3). The internal walls of the church were full of frescoes and mural paintings (Figure 4). It was built in cutting huge rocks at lonely mountains so that the clergies could worship away from man. The spring-water issuing from the nearest rock of the Monastery were consented as sacred. The Monastery repaired many times from first building date, and the finally reparation performed in 1860, but this unique historical buildings was plundered many times by the robbers of historical-heritages belonging to various nations. It has been restored by The Ministry of Culture and Tourism Republic of Turkey according

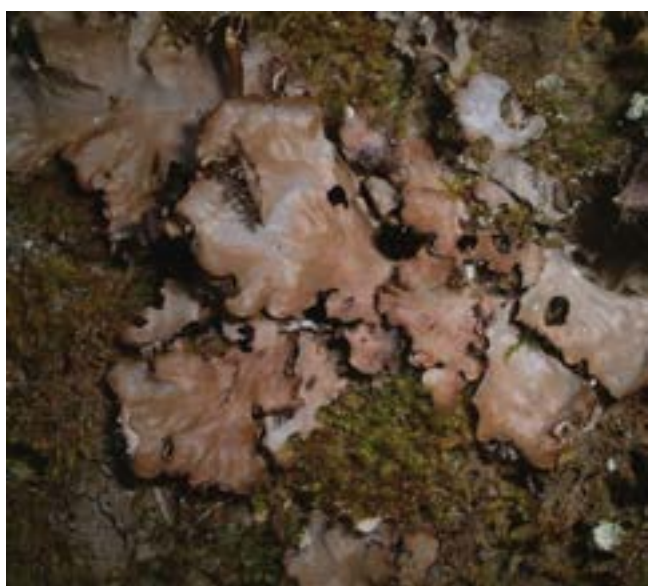
**Figure 6:** The colonization of lichens and mosses on the lower parts of the Monastery walls.

Our observations indicated that the external walls of the Sumela Monastery showed clear indications of biodeterioration, including stone disaggregation and the presence of lichens and mosses which were abundantly colonized on the lower parts of the walls and free stones (Figure 6). Algal and fungal cells were very abundant in the internal fragments of the splitting rock (Figure 7). Many white spots due to lichens were observed on the stone surfaces. The stone surface is frequently deteriorated due to the action of algae and lichens. It is well known that acid secreted by algae and lichens accelerates the deterioration of stone surfaces [4,20].

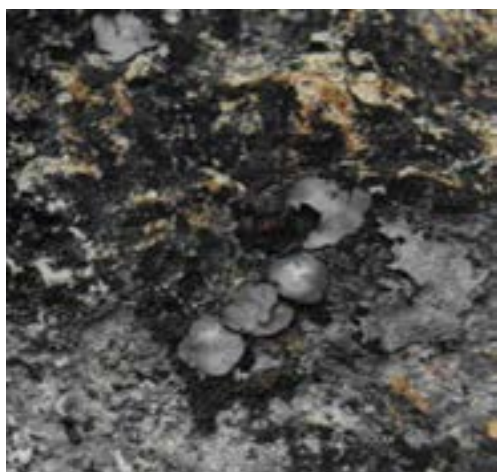
**Figure 8:** The colonization of *Umbilicaria cinereorufescens* on the monastery wall.

Examination of Table 2, and carried out *in situ* investigation, it is seen that the species of lichens such as *Umbilicaria cinereorufescens* (Figure 8), *Candelariella vitellina*, the genus of lichen such as *Collema*

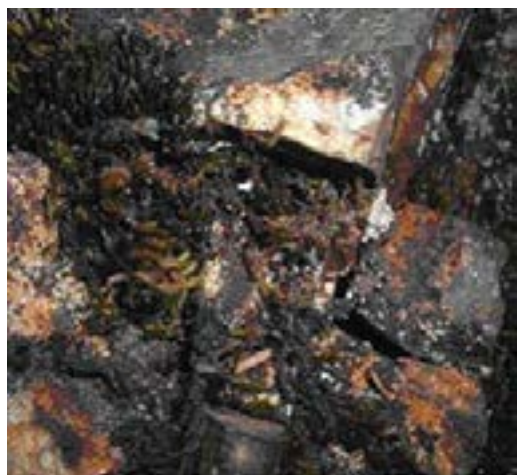
**Figure 13:** The physical and aesthetically detrimental effects and the stone surface coloring of the monastery stones.

Chemoorganotrophic bacteria and fungi are often present in the surface biofilms on the stones and use organic substrates such as hydrogen, carbon and an energy source. They commonly excrete complexing biocorrosive organic acid (i.e., oxalic, oxaloacetic, citric, gluconic, glyoxalic, fumaric) or weaken the mineral lattice by the oxidation of metal cations such as  $\text{Fe}^{+2}$ , or  $\text{Mn}^{+2}$ . These acids are efficient for rather slowly-soluble cations such as Ca, Al, Si, Fe, Mn and Mg from minerals forming stable complexes. It has been shown that biogenic organic acids are considerably more effective in mineral mobilization than inorganic acids and are considered as one of the major damaging agents affecting stone deterioration [4]. The way of deterioration on the stone surface, as a loss of esthetical value, has been seen in Figures 4-13.
