Landslides Mapping and Susceptibility Analysis Using RS and QGIS Techniques in Chiweta Area, Northern Malawi

Abstract

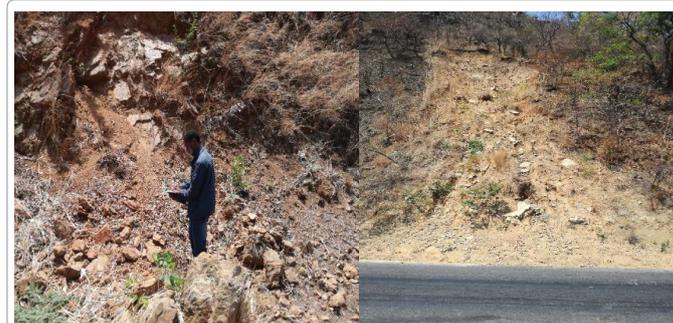
Figure 3: Landslides recording and measurement during field survey.

Ground-truth was conducted to establish and authenticate identified spots of landslides using satellite images. The points were recorded using a Geographic Positioning System (GPS) since the size of the features is not very huge. The dip angle and dip direction of the rock outcrops were recorded using a Brunton compass and the distance of the landslides from the road and/or streams was measured using a tape measure. Geological and structural mapping was also carried out during the landslides mapping to ascertain the literature information on the geology and structures. The data collected include: lithological units, discontinuities and their attributes and weathering conditions of the outcrops. Potential sites of debris and/or rock fall were also observed but not recorded alongside landslides. Geomorphological observations were done to appreciate and compare terrain view with the remotely acquired data from satellite images (Figure 3).

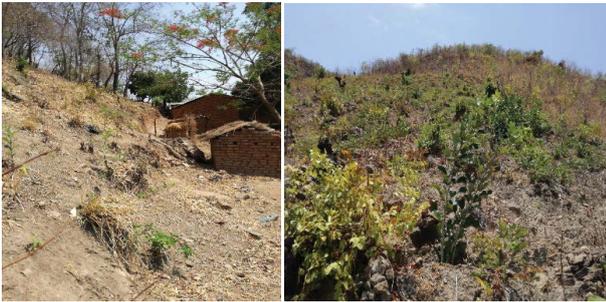
Figure 6: Structures built on the mountain base with unsupported landscaping and cassava field on the slopes of one of the many mountain ranges in the area.

complexity renders the lithological units vulnerable to landslides. It should be noted from Figure 5 that the sedimentary rocks predominate in the area which raises the landslides susceptibility. A few landslides also occurred on degraded slopes of highly weathered metamorphic rocks whose outcrops are cut on the hillslopes. The cut faces have a poor drainage mechanisms and are not reinforced with no regular maintenance (Figures 4-6).
