Performance Assessment of Small-Scale Irrigation Schemes: A Case Study of Upper Blue Nile, East Dangila Woreda, Ethiopia

Biniam Adane^{1*}, Fiseha Behulu² and Dawud Temam³

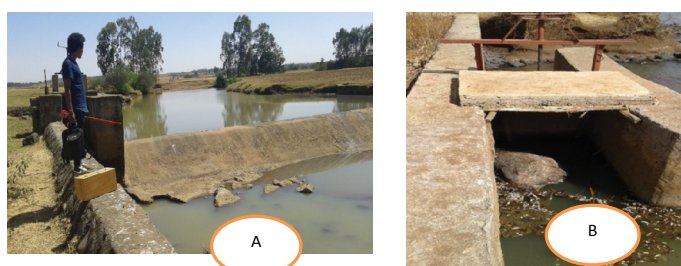
Figure 2. Cause of water shortage in the conveyance.

The analysis show that the actual flows to planned flows were not good specially two schemes that are Ashar and Zuma-1. The reason for low performance of water delivery of Ashar and Zuma-1 schemes are the failures of head regulator gate, unable to fully open of the gates and the inlet of the canal were closed by trash materials and died animals. These schemes need high response of maintenance of diversion headwork, inlets of the canal, head regulator and irrigation conveyance systems. Zuma-2, and Upper Quashine are performed 87 and 95 percent the water delivery system (Figure 2).

A: Zuma-1 seepage of weir body B: Ashar head regulator closed by died animals

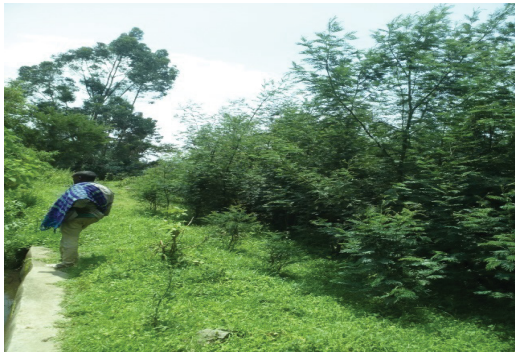
Figure 3. Plant cultivation in the irrigable land.

The ratios of actual area irrigated to planned area to be irrigated were greater than 76 percent. This means these schemes are good performance with regard to irrigated land of the system. But discharge delivery conveyance structure failures leads to seepage and lose of water and farmers grow plants instead of cultivated crops on the irrigable command

area were increased through time (Figure 3).

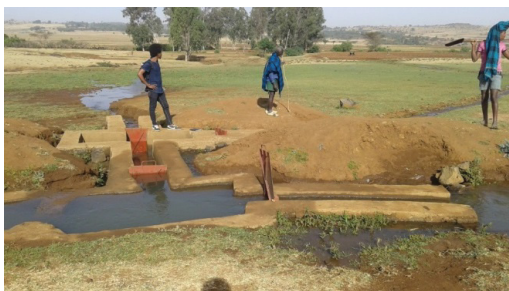
Figure 4. Ashar main canal division gates unable to control water loss.

Some schemes, the conveyance systems are not well organized by WUAs or farmers and the broken division boxes and conveyance canals were not maintained when failures occurred (Figure 4).
