Potential of Sentinel-1 and 2 to Assess Flooded Areas

Abstract

This paper illustrates the potential of Sentinel-1 and -2 for flood detection, mapping and characterization with the aim of establishing policies and procedures that need to be followed in order to lower the impact of future floods. The study area is located in Ras Baalbeck, where highlands meet vast plain area. As it relatively contains poor infrastructures and where income is mainly based on agriculture, flood prevention and mitigation initiatives are much needed. Multiple field visits were conducted to identify the affected areas. Based on the later and while computing thresholds, we did classify multiple satellite imageries into damaged and un-damaged areas. The results achieved were produced under Geographical Information System (GIS)-based software. The adopted methodology is described followed by an analysis of future perspectives. The flooded areas extended 5.08 km² and over two major villages. While Sentinel-2 generated acceptable results, Sentinel-1 did not show any difference between affected and non-affected area in term of soil water content. Still, with their high spatial and temporal resolutions, these

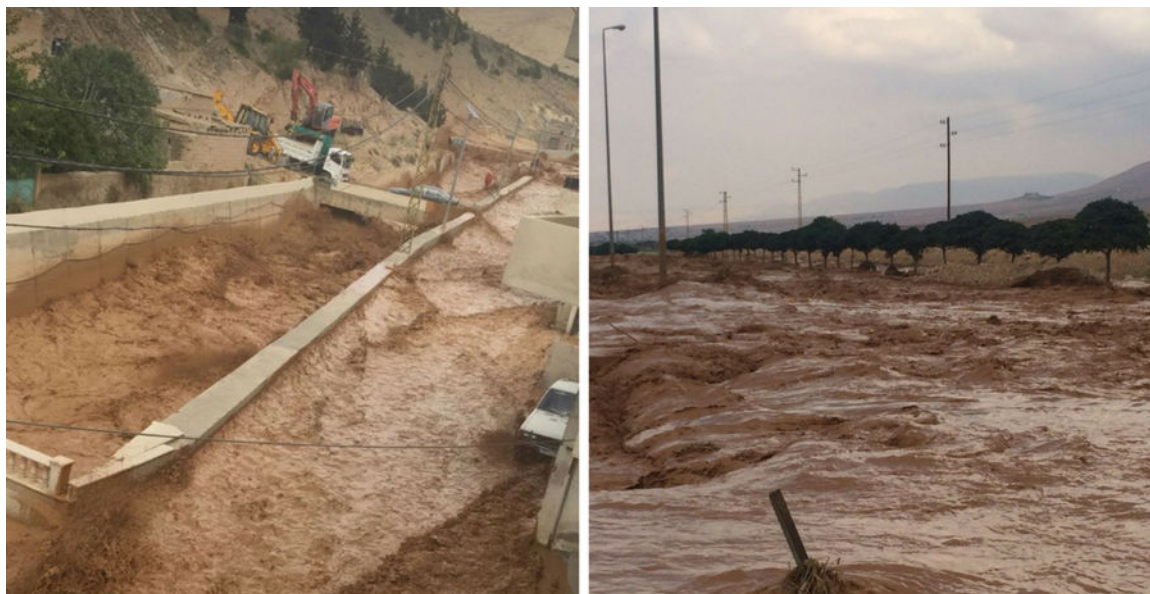
Figure 1: Some of the Ras Baalbek flood images (Courtesy: www.the961.com).

More recently, heavy rain in the heights of Anti-Lebanon mountain chains on June 13th, 2018 resulted in torrential floods that took the life of a woman and led to enormous damage in the region (Figure 1).

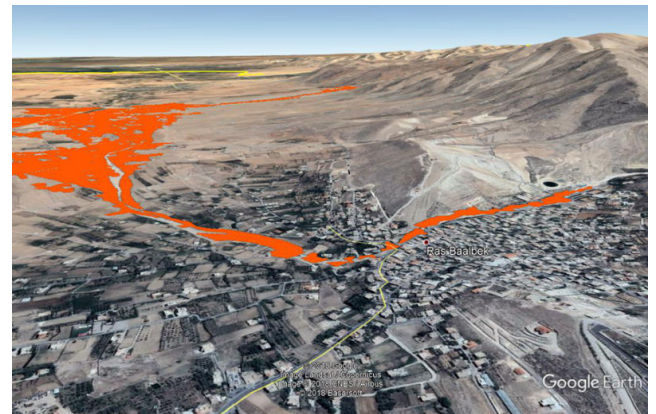
Figure 3: A 3-D representation of the flooded areas.

As shown in Figure 2, the flooded areas extended 5.08 km² from Ras Baalbek to Qaa. More precisely, on the flood day, several areas were traversed including Bsatine Al Ras, Mandjakiyeh, Ouadi Al Qaa, and then across the Lebanese-Syrian borders to Riblah in Syria. This satellite image corresponds to June 15th, 2018, two days following the flood. Thus, some flooded areas could not be well documented. Even though, it appears that many agriculture fields, added to urban areas, have been impacted by the flood. Figure 3 highlights the 3D spatial

distribution of the flood, which appears to be headed from two major itineraries in the nearby mountains. It also shows how this flood has entered the Ras Baalbek town, resulting in major damage along the moving with high velocity front.

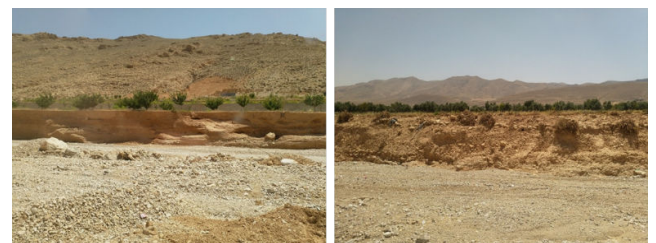
Figure 4: Photos of the flood stream as well as some crops cultivated nearby.

Photos (Figures 4-6) captured in field visits show that at the proximity of the flood stream several crops' types exist. Even though it has a relatively huge stream, the last flood event has reached these plots affecting local crops. Moreover, an ancient wall (Figure 5), considered last seen in the middle of the last century, reappears mainly due to the erosion that coincided with the flood. Because of that, the stream width has widen up to three meters. Also, a new soil layer appears following the flood (Figure 6). According to local residents, it was transported from the nearby high mountains (namely, Younin) and traveled a long distance. This soil layer shows low adaptability to the high temperature and dryness in the area, rendering it inadequate for agriculture. More precisely, the fine sediments formed are capping with cracks when drying and interfering with the emergence of new seedlings.

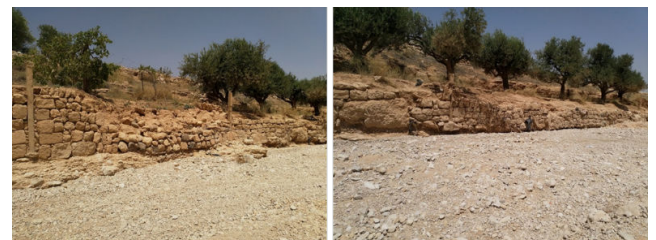
Figure 5: The ancient wall near the flood stream that few remembered its existence.

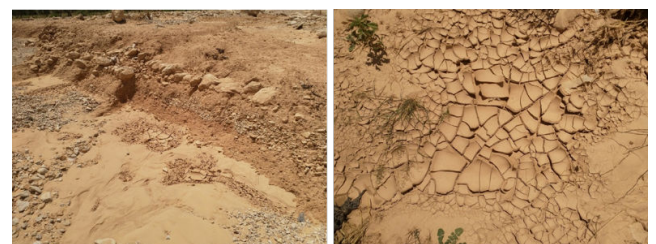
Figure 6: The dried new soil layer that appears following the flood.
