The Case of a Job Well Done?

Abstract

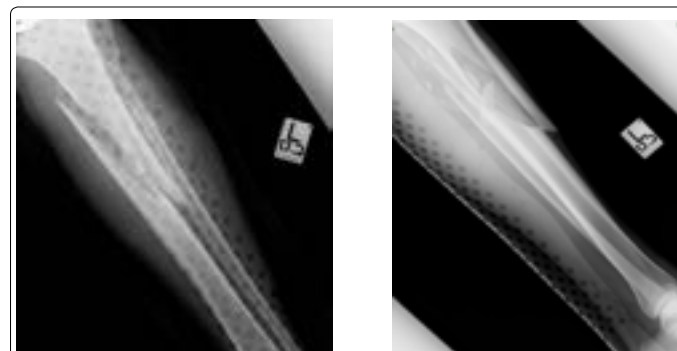
Figure 1: X-ray of Lt. tibia and fibula demonstrating an open fracture due to gun shoot injury, on arrival day.

A 41-year-old man was brought to the emergency trauma room after sustaining a high velocity gunshot injury to the Lt tibia. Pre-hospital care included tourniquet placement above the knee. On arrival, the patient was hemodynamically and respiratory stable, fully alert, Glasgow Coma Scale 15 and Revised Trauma Score of 12 (maximal scoring), with the only obvious sign of injury being the entry and exit wounds caused by the gunshot injury with an open fracture of the Left

proximal tibia (Figure 1). General examination and initial trauma series radiographs were normal. Dorsalis pedis pulse was palpable and no ischemic damage was observed after removal of the tourniquet.

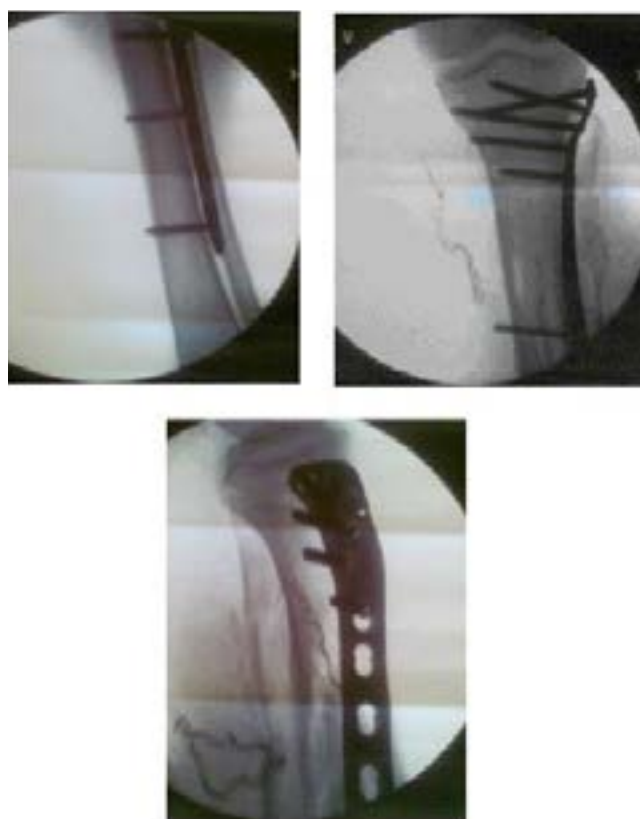
Figure 2: Post plating intraoperative X-ray.

surgical team preformed a closed reduction and internal fixation with LCP 4.5 mm (Synthes) plate and screws through a lateral incision in a minimal invasive technique (Figure 2).

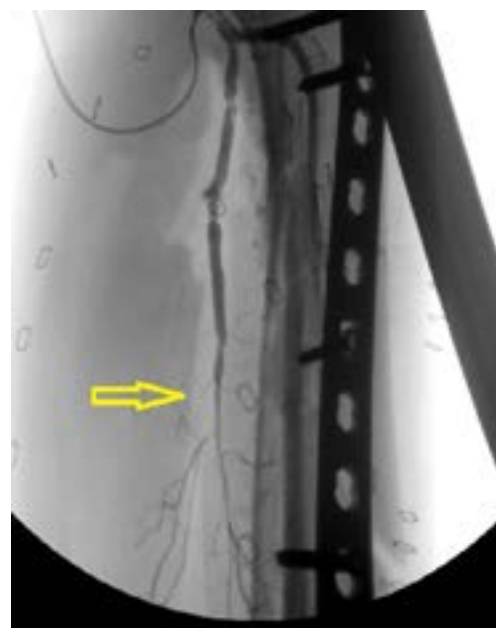
Figure 3A: Selective angiography demonstrating a spastic tibialis posterior artery (large arrow).

Angiography was done on the operating table – it showed a small spastic tibialis posterior artery, and a decision was made to try and fix the anterior tibial artery as well. Selective angiography demonstrated the tibialis anterior pressed between the tibia and the plate with complete obstruction (Figure 3).

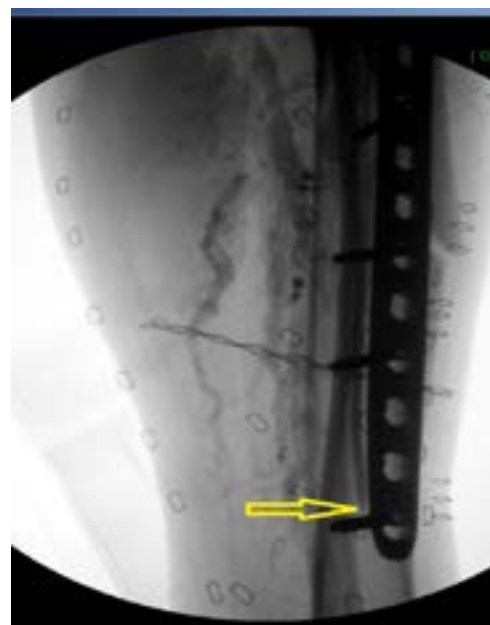
Figure 3B: Tibialis anterior artery compressed between the bone and the plate, showing a complete stop sign (arrow).

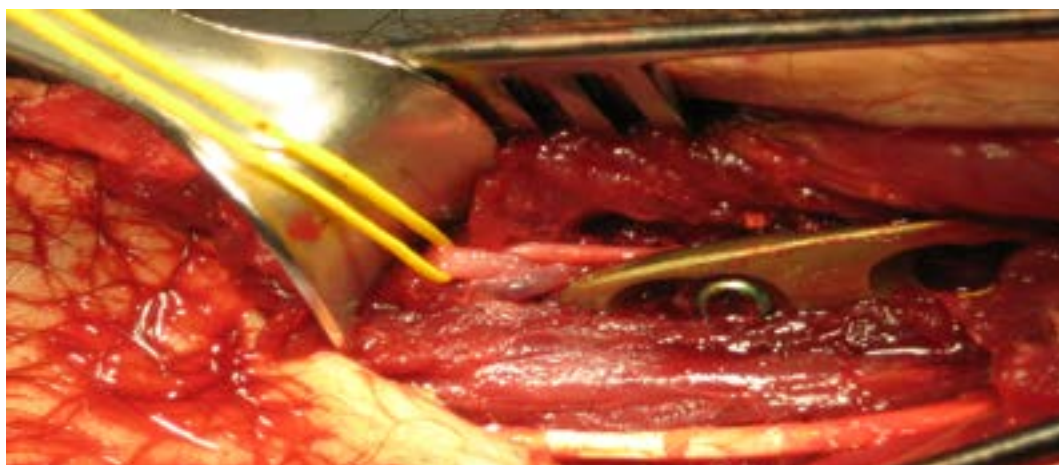
Figure 4: Anterior tibial artery and vein compressed under the distal part of the plate.

In our case, no pseudoaneurysm developed, rather true ischemia appeared shortly after plate fixation, as a result of direct plate compression over the ATA, and as in the latter case report by Van Hensbroek et al. [11] vascular surgery intervention was mandatory.

The plate was immediately removed and the artery was reconstructed using the saphenous vein from the uninjured leg (Figures 4 and 5). At the end of the surgery a good Doppler signal sounded on both arteries. A cross knee external fixator was placed to stabilize the fracture and the patient was taken to the intensive care unit.

Even though this complication is extremely rare, we think that it is most likely preventable. The direct pressure of the plate on the ATA could have been noticed sooner during the first surgery if a larger distal incision would have been used, instead of a stab incision, and a visual confirmation of the distal contact area between the bone and the plate was carefully examined with no soft tissue entrapment verified. Another useful option would have been to use a Doppler device to verify the existence of distal pulses at the end of the plating.

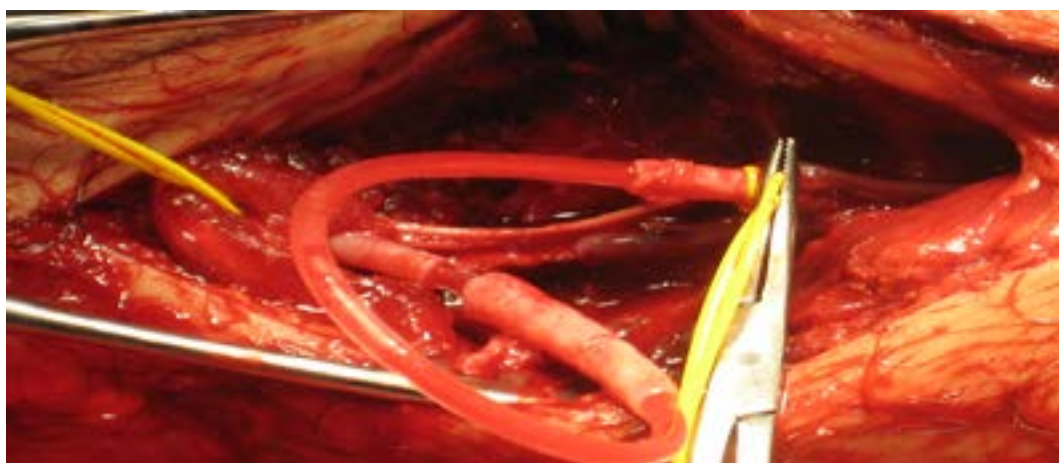
Figure 5: Reconstruction of the anterior tibial artery after plate removal.
