The Unexploited Role of Transperineal Ultrasound Scan Examinations in Patients with Pelvic Pain

Keywords: Transperineal ultrasound; Pelvic pain; Rectovaginal endometriosis

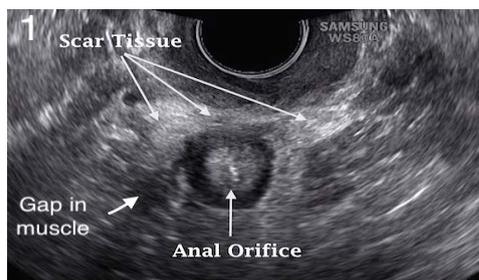
Figure 1: Transperineal ultrasound image across the anal canal showing thick adhesions around the anus and a gap in the muscle on the right side.

A 38-years-old patient presented with superficial dyspareunia and vulval pain while sitting down for 5 years. Superficial inspection of the vulva was unremarkable. The introitus barely admitted two fingers with extreme tenderness. She had vulval renovation surgery previously. Transperineal ultrasound scanning was done. The probe was initially placed on the fourchette in the anterior posterior plane, with the labia separated sideways. A sagittal view of the anal canal and the rectum was obtained first. The probe was then rotated 90° and the hand holding the probe was lifted vertically towards the roof. The circular image of the anus was thus obtained. Extensive scarring was seen around the anal canal mainly anteriorly and on the right side with deficient muscles on the right side (Figure 1). Such an image should alert the surgeon to the difficulty expected while reconstructing the area and the amount of scar tissue necessary to be excised. The patient should also be counselled beforehand about the expected difficult surgery and result of the operation. Without such information, the extent of the operation might not have been visualized before surgery and the patient might not have been counselled appropriately. For comparison purpose, Figure 2 shows a normal anal orifice and intact surrounding muscles.

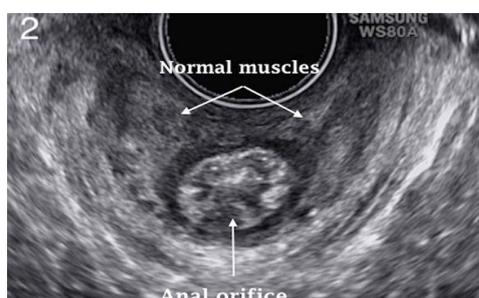
Figure 2: Transperineal ultrasound scan image across the rectum showing normal anal orifice and surrounding muscles, shown for comparison with Figure number 1.

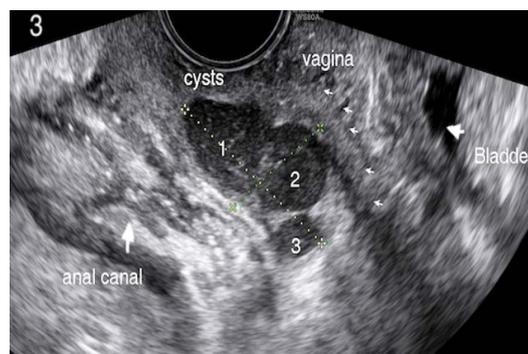
Figure 3: Sagittal transperineal ultrasound scan showing 3 cysts between the rectum and the vagina which is marked by small arrows.

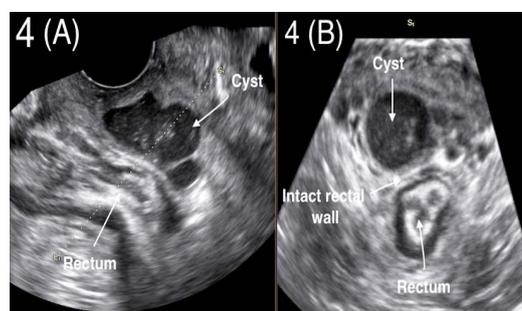
Figure 4 (A and B): (A) Split ultrasound image showing sagittal view of the rectum with 3 cysts anteriorly. (B) is an oblique transection view of the rectum and the middle cyst taken at the level of the dotted line in Figure A.

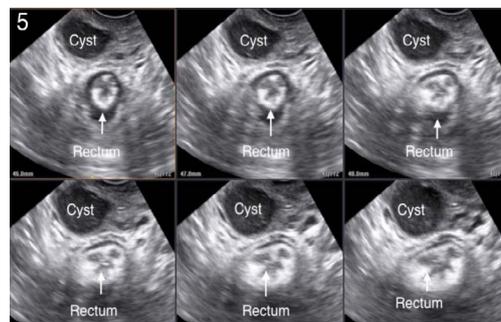
Figure 5: Transverse sequential multiple slices view across the rectum showing no direct connection or communication between the cysts and the rectum.

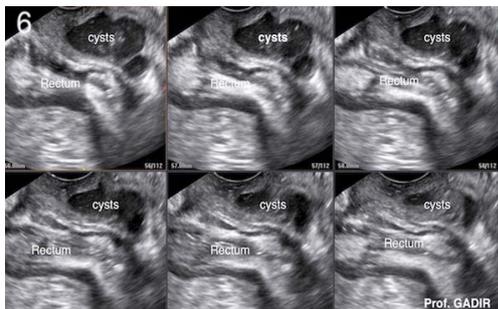
Figure 6: Sequential sagittal multiple slices view of the rectum and the 3 cysts showing no direct connection or communication between the cysts and the rectum.

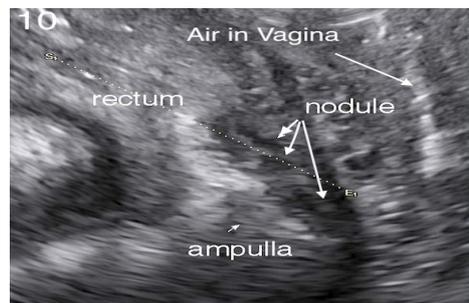
Figure 10: Magnified transperineal ultrasound scan image showing a nodule on the anterior wall of the rectum. The nodule is marked with three arrows.

Transperineal ultrasound scan examination showed a nodule pushing into the rectum at the level of the ampulla (Figure 10). The diagnosis was confirmed by oblique transection of the rectum along the dotted line in image number 10 to show the nodule clearly on the anterior wall of the rectum (Figure 11). Multiplanar view reconstruction (Figure 12) confirmed the exact location of the nodule towards the right side of the anterior wall of the ampulla. It proved to be endometriotic during laparoscopic examination (Figure 13).

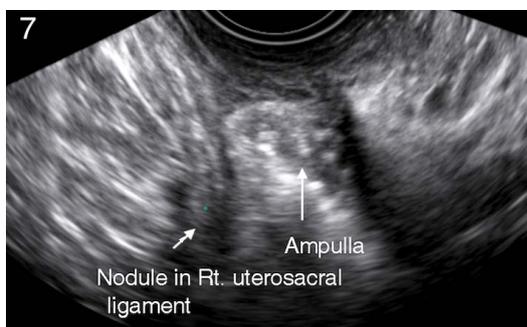
Figure 7: Transperineal ultrasound 2D scan view showing the rectal ampulla with suspected nodule in the right uterosacral ligament.

The right uterosacral ligament was seen thickened and heterogenous (Figure 7). 3D manipulation of the images in two different directions confirmed the diagnosis (Figures 8 and 9). Laparoscopic examination showed an endometriotic nodule along the right uterosacral ligament. The value of 3D manipulation in showing the pathology was clearly demonstrated in this case.

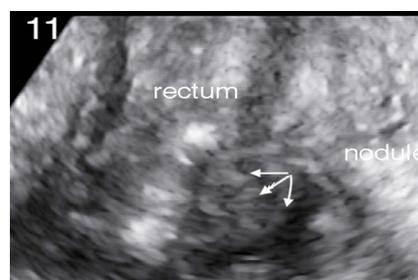
Figure 11: Oblique ultrasound view of the rectum obtained by transection of the rectum along the dotted line in image number 10. It clearly shows a nodule on the anterior wall of the rectum marked with arrows.

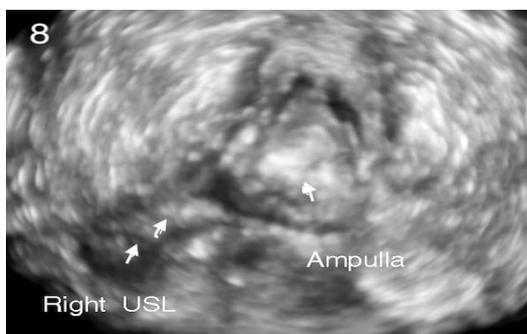
Figure 8: 3D ultrasound view across the ampulla with a thick right uterosacral ligament.

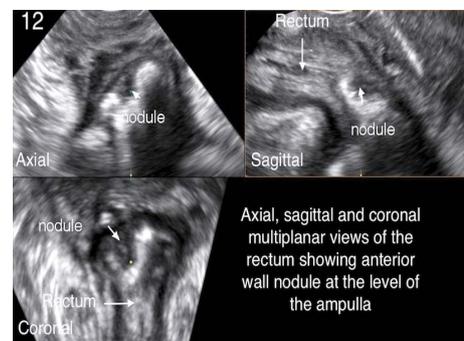
Figure 12: Multiplanar ultrasound view following transperineal ultrasound scan examination. It shows axial, sagittal and coronal views of the rectum with an anterior wall nodule on the right side of the ampulla.

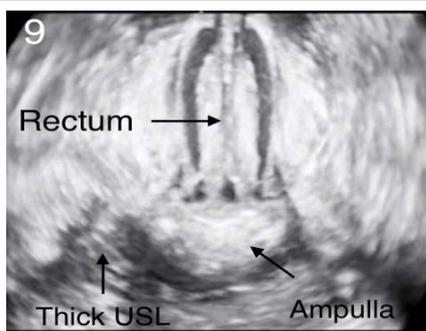
Figure 9: Coronal ultrasound scan view showing the rectum, ampulla and the thick uterosacral ligament.

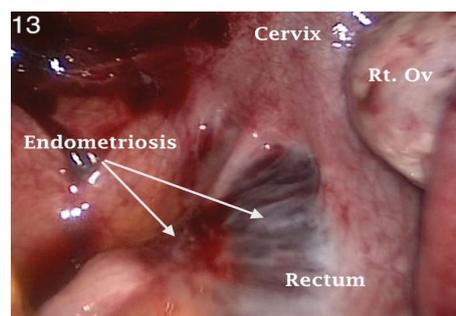
Figure 13: Laparoscopic image showing a large endometriotic nodule on the anterior wall of the rectum, mainly towards the right side.
