Viability of Ulpotha Micro-cascade Rehabilitation with its Indigenous Irrigation Systems-Sri Lanka

Dunstan J Fernando*

Australian High Commission, Colombo, Sri Lanka

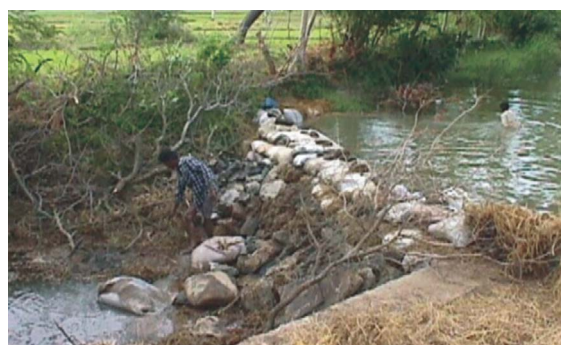
Figure 10: Indigenous Water Storing Practices.

Even though there are rules and regulations, it is not easy to stop forest destruction and degradation in catchments. Even today, Sri Lanka loses around 0.05 ha of forest per annum due to many reasons. This situation invariably impact on cascade resources and sound management practices are also absent for small tank systems. No proper or regular maintenance system operates under DAD. On the other hand, Farmer Organisations (FOs) do not have sufficient funds and technical know-how to establish effective maintenance systems (Figure 10).

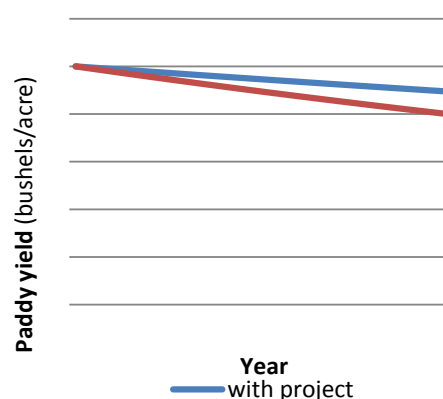
Figure 13: Comparison of Paddy Yields under with and without cascade improvement.

The environmental benefits from reduced erosion have been valued by assuming that it leads to a reduction in the siltation of tanks, and therefore maintain paddy yields [9] at a higher level than without restoration. An estimate of the decline in yields was obtained from Walathewa (a village [10] in the Ulpotha cascade), where the rehabilitation of a tank [11] resulted in an increase in yields from 80 to 100 bushels per acre. It is assumed that this decline would occur over a 30 year period where the cascade and forests were degraded, but effective soil and water conservation measures would reduce the level of erosion and halve the annual rate of decline in paddy yields. The resulting difference in yields is illustrated in Figure 13.
