# Assessment of the Hydraulic Performance of the Drainage System in Dire Dawa Town

The constructed drainage structure was expected to carry the design discharge which generated from the catchment area and dispose safely to the outlet points. The study has mainly focused to assessing current status of drainage system and evaluates the hydraulic performance of the drainage system. The rational methods have been used to calculate proposed discharge and HY-8 software used for culvert analysis. The current drainage status of the towns was poor, the road performance was reduced to deliver, the service life of the road reduced, and the cost for maintaining the road increased, the compression between the proposed and existed carrying capacity of drainage structures showed that the exist drainage structures are hydraulically insufficient. HY 8 result shows the existed culvert was hydraulically insufficient and 50-63.5% of the proposed peak discharge overtopped and flows on the road.

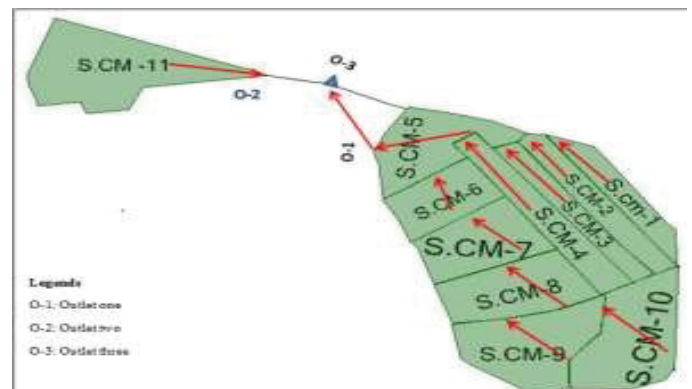
Figure 2. The sub-catchment areas of the study area.

The ARC-GIS 10.4 and Global mapper program was used for the preparations of the study areas of sub-catchment areas, location map preparations of the study area, and land use land cover preparations.

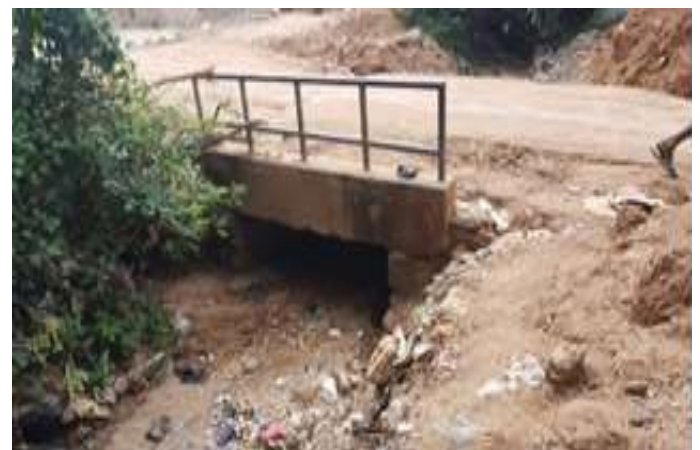
Figure 3. Almost all filled with the sedimentation of side ditches.

From personal observation of the site the drainage system of the town was highly used the rectangular open channel without covering the top part of the channels this leads the channel to filled with wastes, commercial residues,

and the community itself use the channel as a means of the trade area. Those activate create reducing the size of the drainage structure and immediately it creates an overtopping of channels and flow on the roads also some portion of the drainage blocked with waste crates water stagnation for long period of times.

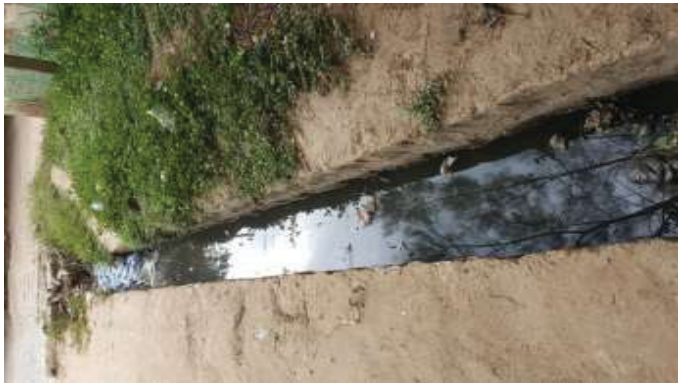
**Figure 4.** Solid waste and dust accumulation in the drainage system and creates water stagnation in the side channel.

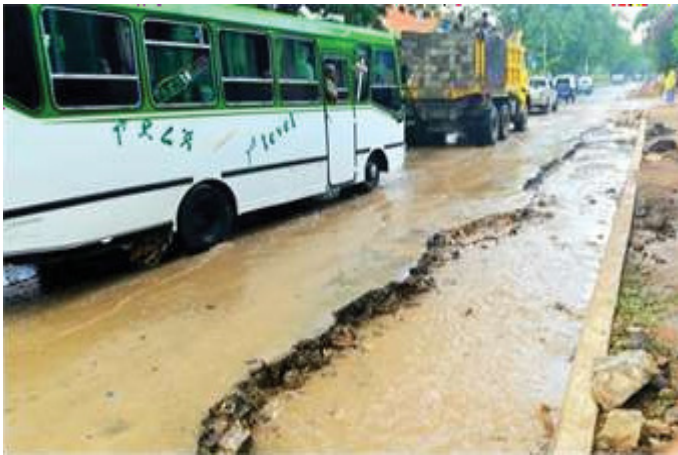
**Figure 5.** Flooding to both the right and left side of the drainage system.

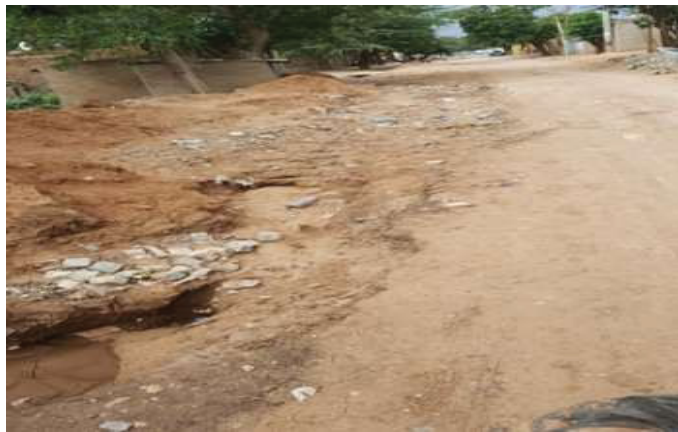
**Figure 6.** Eroded roads and gully formations due to lack of side ditches.

Still, areas without drainage channels construction exist and the flow from those places create an overflow on the road and deteriorates the side of the roads highly this happens due to poor drainage alignment system with the roads.
