## Breakage of Automotive Spring Washer during Twist Test: A Metallurgical Analysis

### Abstract

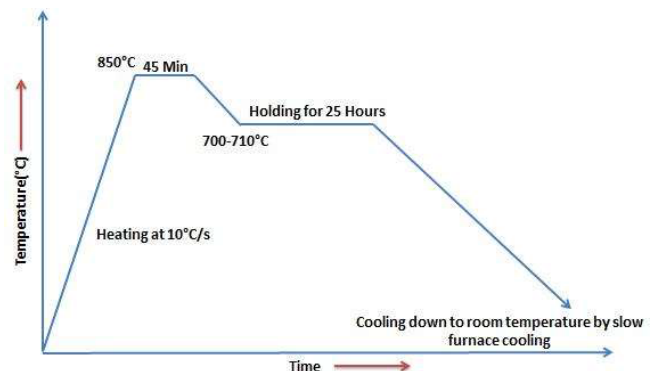
**Figure 5a:** Heat Treatment cycle.

The flat wire samples (3 and 4) of the failed lots were subjected to heat treatment to find out the effect of the heat treatment cycle. First the component was heated above austenizing temperature at around 850°C, followed by cooling at a temperature below the eutectoid temperature 700-710°C. It was then hold for a prolonged period (22-25 Hours) and furnace cooling was done at a very slow rate with appropriate soaking time (Figure 5a). After heat treatment distribution of spheroidized carbide was found more uniform in spring washer samples after heat treatment than that of rejected samples (Figures 5b and 5c).
