Study on Ultimate Seismic Behavior and Repair Method of Damaged Steel Frames

Abstract

Keywords: Steel frame; Reparability; Repair method; Strength ratio; Ultimate state; Partial frame

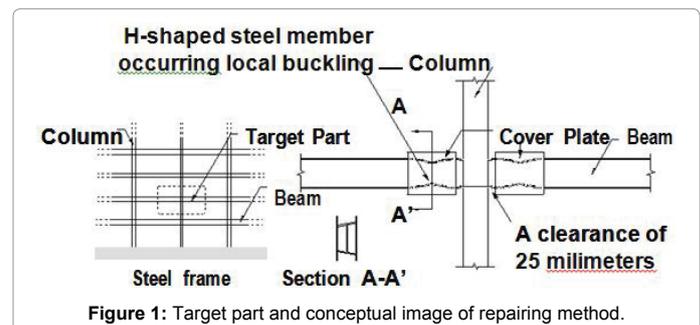
To investigate the ultimate state and predominant failure mode on repaired steel frame, the test specimen is designed as a half size scaled - partial steel frame.

The column to beam connection is through - diaphragm type. The beam flange with non-scallop is welded the diaphragm by full penetration.
