## Study on Ultimate State and Mechanical Characteristics of Connection Joint of Damaged H-Shaped Bracing Structure

**Keywords:** Steel braced structure; Repair method; Gusset plate

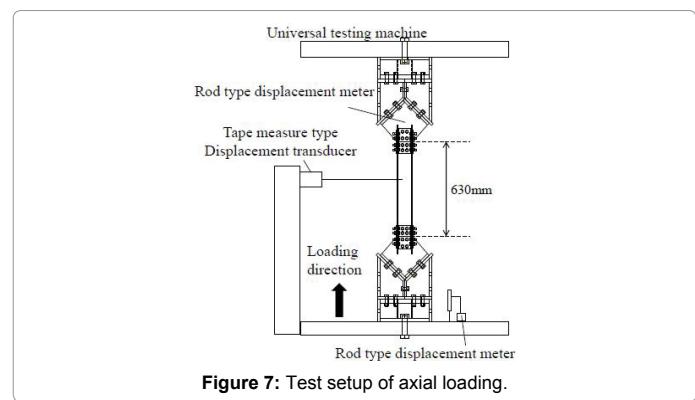
Figure 7: Test setup of axial loading.

Figure 7 presents the test setup and test specimen which reappears a plane of bracing structure. Both ends of test specimen are supported as fix condition. The procedure of experimental study is as follows:

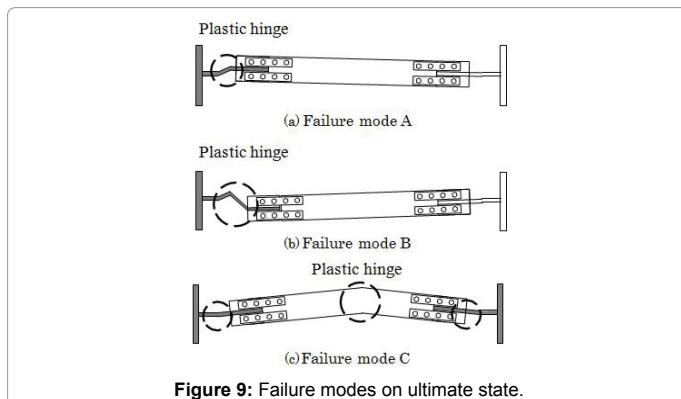
Figure 9: Failure modes on ultimate state.

During loading test, 3 kinds of failure modes were observed as shown in Figure 9. The relation of axial force N-axial displacement  $\delta$  curves of monotonic loading test are shown in Figure 10. Table 4 comparers the test results of original and repaired test specimen.

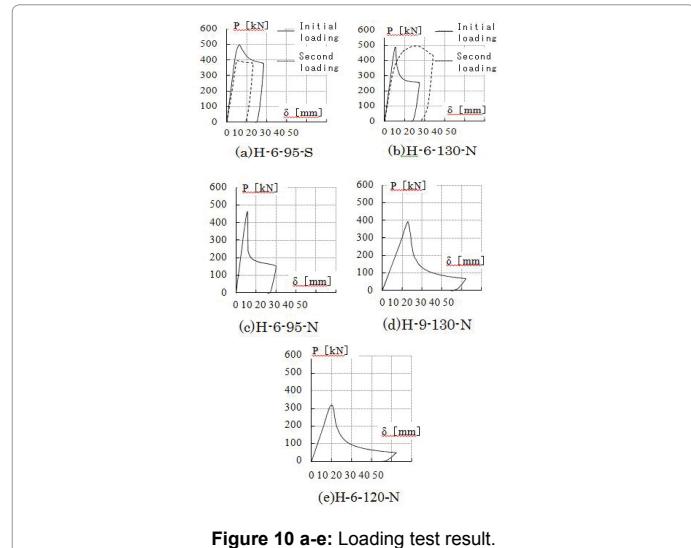
Figure 10 a-e: Loading test result.

**H-6-95-S specimen:** In case of H-6-95-S as shown in Figure 10a, according to the results of strain, the brace member remained within elastic range. From the ultimate state of test specimen, the plastic failure

**H-6-120-N and H-9-130-N specimen:** In case of H-6-120-S and H-9-130-N as shown in Figures 10b and 10c from the ultimate states of test specimen, the plastic failure mechanism was formed by occurrence of one plastic hinges on brace member, and both joint end behaved as pin (herein after referred to as "failure mode C"). And also, the out of plane deformation on gusset plate was observed too.

**H-6-120-N and H-9-130-N specimen:** In case of H-6-120-S and H-9-130-N as shown in Figures 10d and 10e, from the ultimate states of test specimen, the plastic failure mechanism was formed by occurrence of one plastic hinges on brace member, and both joint end behaved as pin (herein after referred to as "failure mode C"). And also, the out of plane deformation on gusset plate was observed too.

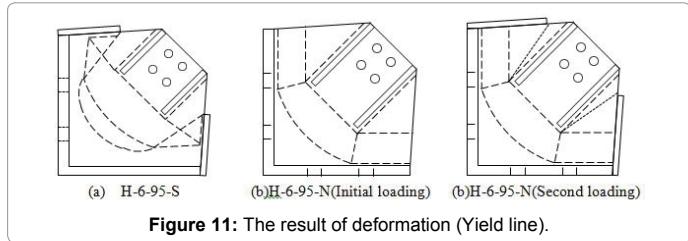
Figure 11: The result of deformation (Yield line).

**Ultimate state and repair method on damaged test specimen:** From the ultimate state of test specimens, the plastic failure mechanism and yield lines were summarized in Figure 11. In cases of H-6-95-N, H-6-120-N and H-9-130-N specimens, the excessive plastic deformations were generated, so it was decided that they cannot be adopted by repair method as previous mentioned on section 1.1.

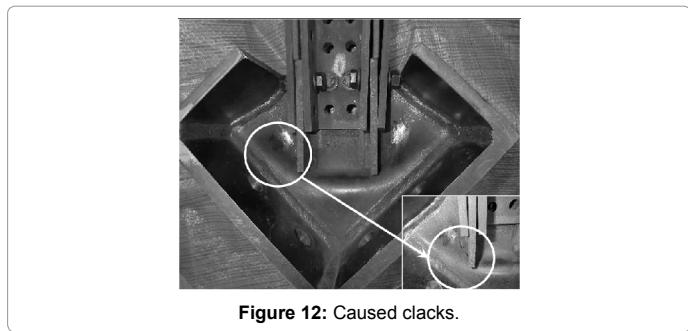
Figure 12: Caused cracks.

**H-6-130-N specimen:** In case of H-6-130-N, the damaged test specimen was repaired. From the second loading test, a crack was observed on gusset plate around weld part of fin stiffener as shown in Figure 12, however, the side stiffener did not yield.

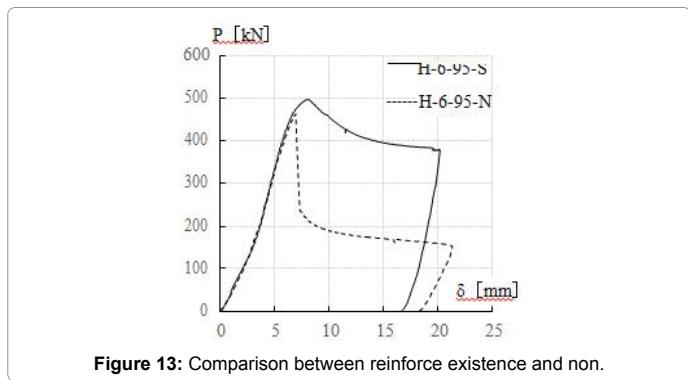
Figure 13: Comparison between reinforce existence and non.

**Effect of side stiffener after repair:** The comparison of test results of repaired specimen with side stiffener and repaired specimen without side stiffener is shown in Figure 13. From the comparison of Figure 13, it can be confirmed that initial stiffness presents almost same, however, the maximum load increase about 10% by using side stiffener. Moreover, it can be confirm that stable strength after buckling increase about 2.5 times.

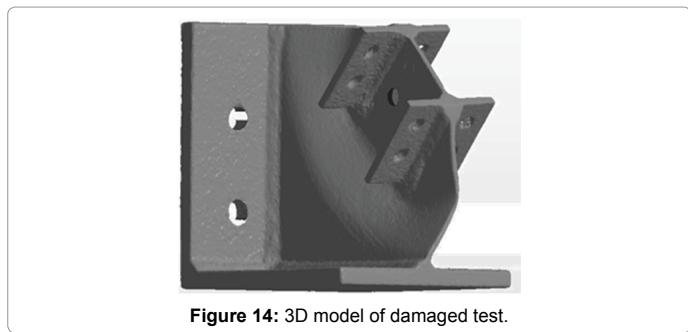
Figure 14: 3D model of damaged test.

The ultimate state of damaged gusset plate after plastic deformation is measured and converted into 3D data by "Photo Scan". For example, the 3D model of H-6-95-N specimen is described in Figure 14. The 3D-model is made by 180 photo data which are taken from deferent heights and 360 degrees. Also, "Auto desk Netfabb Standard2017" and "ArtecStudio9" is used for measuring 3D model.

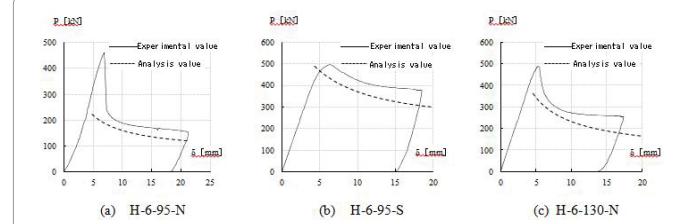
Figure 16: Comparison between test results and analytical results.

Figure 16 compares the load-displacement curve of analytical results and test results during ultimate state. From the comparison of Figure 10, it can be confirmed that the analytical model can chase the test results well.
