## The Repair Method of Damaged H-shaped Steel Members and Experimental Study on Recovery after Repair

Tomoe Onoda\*, Takumi Ito, Kenjiro Mori, Hiromu Fuse and Changhoon Choi

Department of Architecture, Tokyo University of Science, Japan

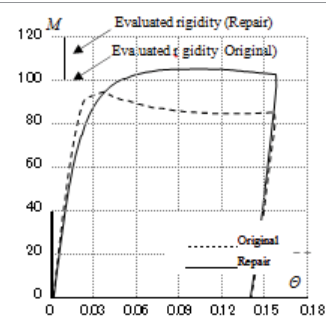
**Figure 13:** Comparison of the results of theoretical initial rigidity and M-θ curves.

**(a) NS150-3.2C-M**

**(b) NS150-4.5C-M**

plate are shown in Figures 12 and 13. From these results, it is confirmed that initial rigidity could be controlled by changing the thickness of cover plate. Furthermore, initial rigidity after repair in this study became almost equal to initial rigidity before damaged.
