Case Report

An Early Migration of an Implantable Port Catheter: Where and how should we Place the Catheter Tip?

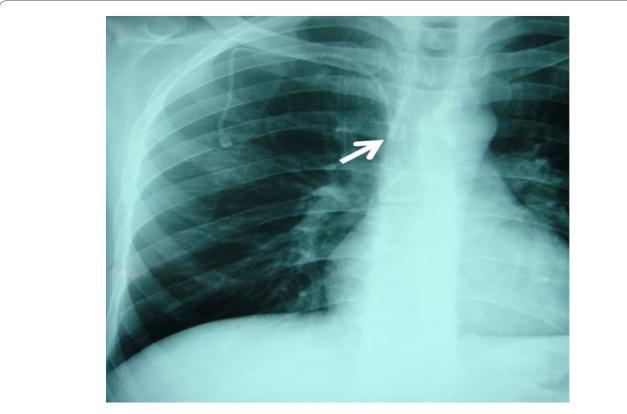
Figure 1: A post-procedure radiographic image showing the catheter tip position (arrow).

We describe a case of a 26-year-old man, with normal Body Mass Index (BMI), who underwent curative surgery and adjuvant chemotherapy for locally invasive sigmoid adenocarcinoma. The chemotherapy drugs were administered through an implantable venous access device (BardPort[®]). Under local anesthesia, the right Subclavian Vein (SCV) was accessed percutaneously by the infraclavicular approach. The catheter tip was positioned without radioscopic imageguided assistance. A post-procedure Chest X-ray (CXR) (Figure 1) confirmed that the catheter tip lay outside the cardiac cavities, and was positioned above the carina in line with current guidelines [1].

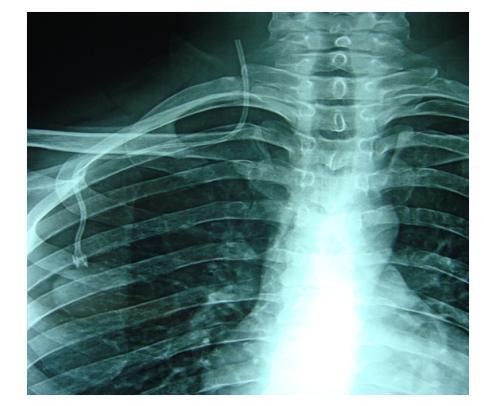
Figure 2: The catheter tip migration in the ipsilateral IJV.

onset pain in the right side of the neck. On clinical examination, there was a significant restriction in the range of cervical movement due to torticollis. There was a poorly defined mass in the area of the right sternocleidomastoid muscle. Ultrasonography of the draining veins revealed a migration of the catheter tip into the lumen of the Internal Jugular Vein (IJV), and a small catheter-related central vein thrombosis. This migration was also confirmed by chest radiography (Figure 2). Due to the potential risk of pulmonary embolism, low molecular weight heparin therapy was started. The neck edema and discomfort resolved within two days. After 7 days, the port was removed and a second implantable port with an open-ended catheter was inserted in the left side with the same approach. The correct position of the catheter tip was confirmed by CXR. The patient was discharged before his next session of chemotherapy.
