Assessment of the Impacts of Refinery Effluent on the Physico-chemical Properties of Ubeji Creek, Delta State, Nigeria

Odesiri-Eruteyan Eunice*, Obukohwo Frank, Uhribo Voke and Asibor Godwin

Citation: Eunice OE, Frank O, Voke U, Godwin A (2017) Assessment of the Impacts of Refinery Effluent on the Physico-chemical Properties of Ubeji Creek, Delta State, Nigeria. J Environ Anal Toxicol 7: 428. doi: 10.4172/2161-0525.1000428

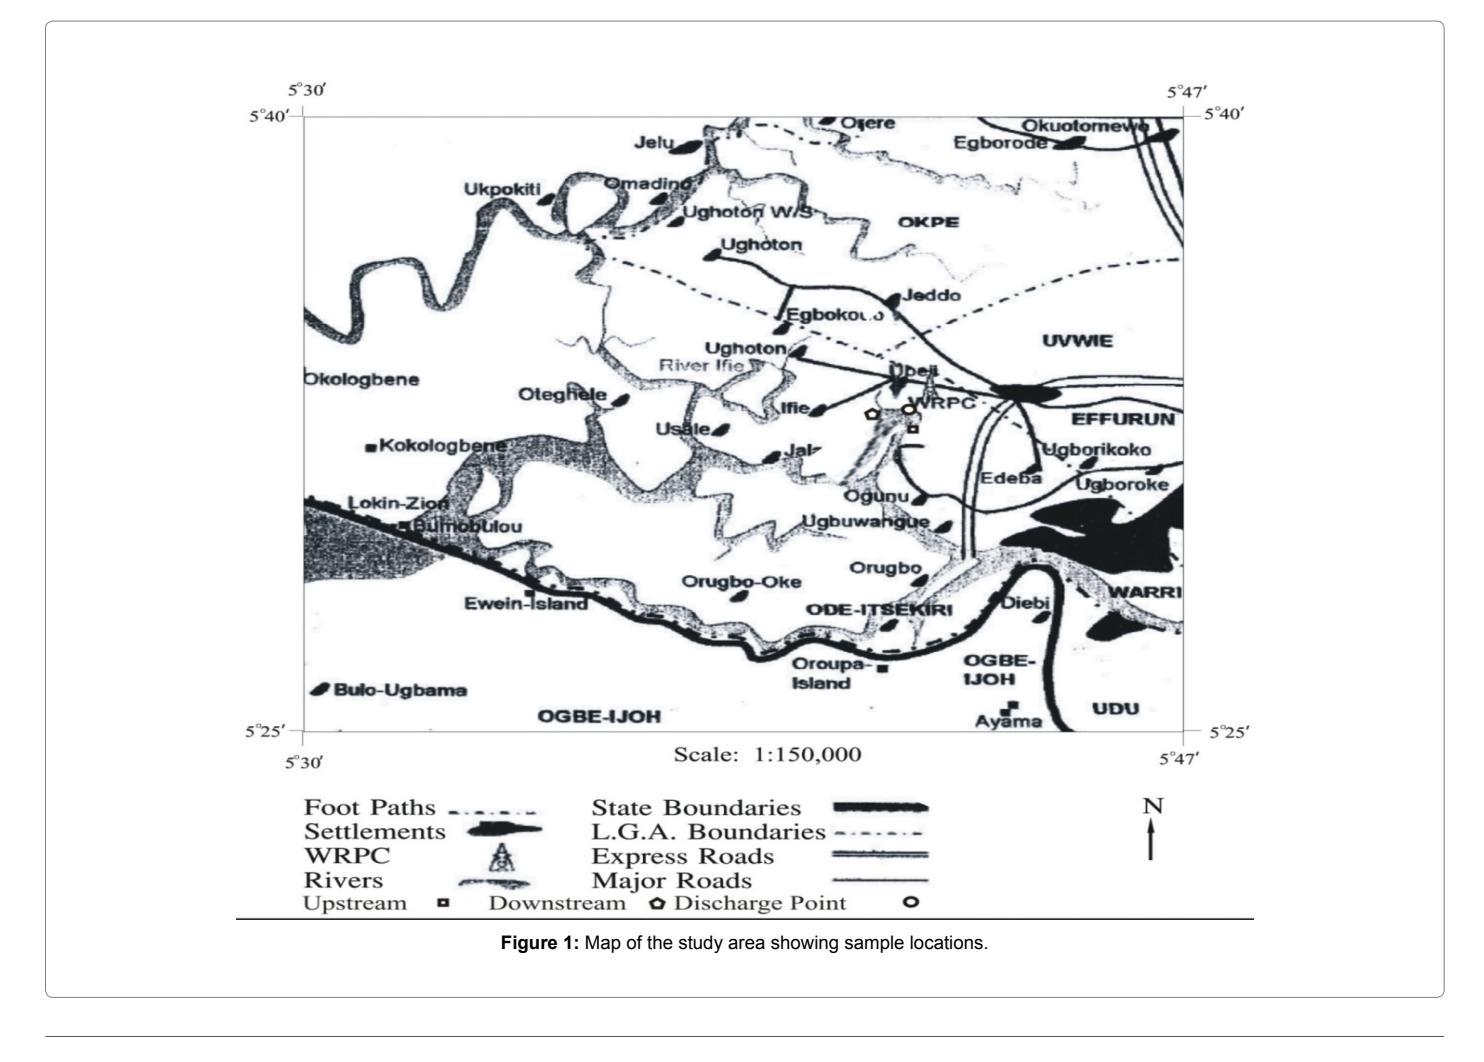
The study area includes Ubeji creek, Warri Refinery and Petrochemical Company (WRPC) and surrounding communities in Delta State Nigeria. The refinery is bounded by three communities; Ekpan, Jeddo and Ubeji. It is located between latitude 5°25'N and 5°40'N and longitude 5°30'E and 5°47'E. Industrial wastes and effluents are discharged into Ubeji creek through some minor creeklets. The Creek flows through Crawford Creek into Warri river which eventually empties into the Atlantic Ocean through the Bight of Benin (Figure 1).

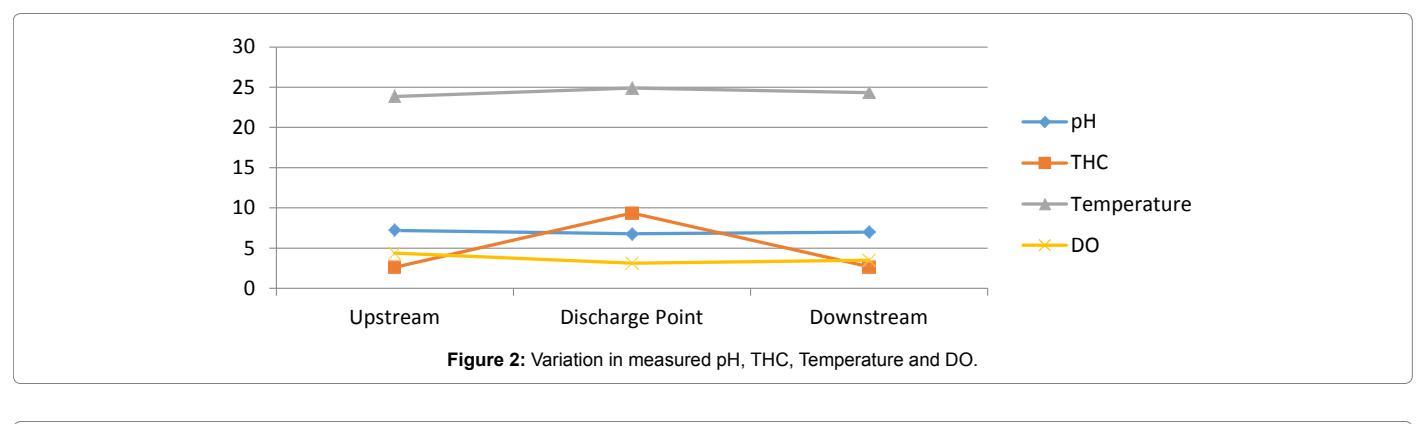
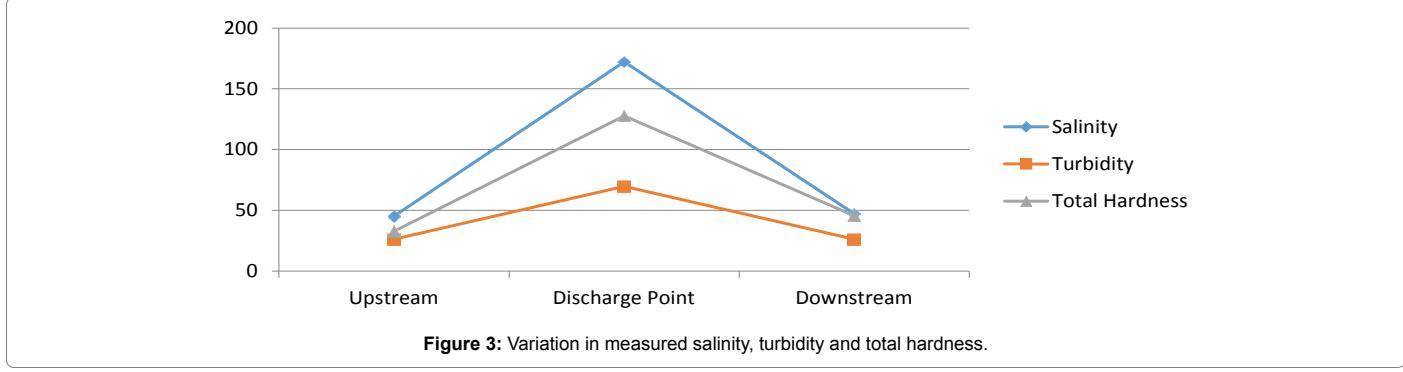
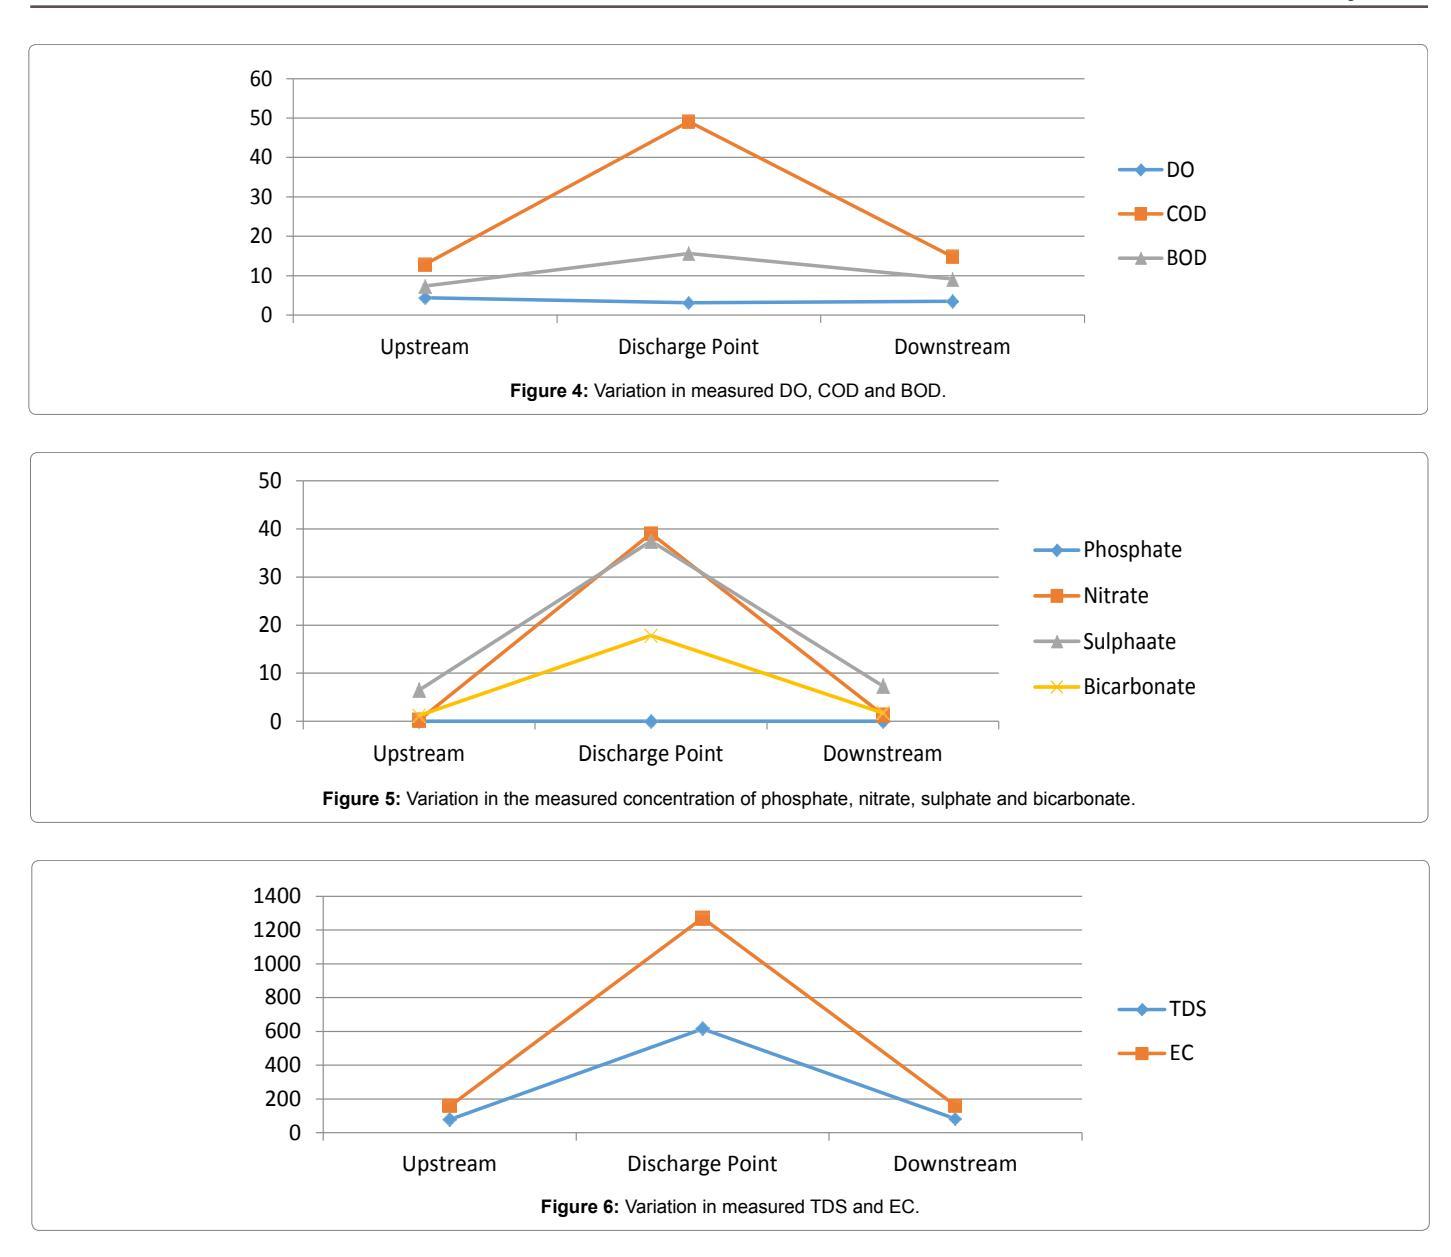
The physical and chemical parameters investigated have been widely used to assess the impact of effluents on the water quality of African lakes, ponds, reservoir, freshwater and marine waters [10]. The various parameters assessed are presented in Figures 2-6.

The amount of total suspended solids of the effluent sample (12.63 mg/l) showed to have a lower value relative to the water samples from both the upstream and downstream sections (13.34 mg/l and 13.03 mg/l respectively) of the study area. The water and effluent samples failed to comply with FEPA allowable limit of 10.0 mg/l. The relatively higher TSS values in water samples from both sections of the water course suggests that wastes are being added to the water from other sources apart from the industrial effluents. This may be as a result of rainstorm deposition or runoffs from the creek's surrounding. The temperature and pH of the effluent as well as that of the upstream and downstream sections of the water course were within DPR and FEPA limits [11].

TDS measured at the discharge point was 615.30 mg/l and was within both DPR and FEPA limits but above the WHO potable water limit of 500 mg/l. The values at the upstream and downstream (78.20

mg/l and 81.40 mg/l respectively) satisfy WHO potable water limit showing a corresponding increase of about 4.09%. The high. TDS in water can cause changes in taste, excessive scaling in water pipes, water heaters, boilers and household appliances.

Dissolved oxygen (DO) is the amount of oxygen in a water or effluent sample. Moderate DO levels in surface water body indicate the ability to support aquatic life. Organic wastes utilize DO for biological decomposition and inorganic compounds also utilize oxygen in reduced state for oxidation. DO level was found to have dropped from 4.37 mg/l in the upstream section to 3.48 mg/l in the downstream section of the creek. This may be as a result of the continuous introduction of effluents midstream, reduction in the rate of atmospheric oxygen absorption or reduced rate of photosynthesis in the downstream segment of the creek. The decreased DO level at the downstream section of the creek may also be due to the turbulence in the river water and increased competition for oxygen within the ecosystem. The high organic and inorganic pollutants received by water bodies through the discharge of industrial, sewage and solid wastes, require a high oxygen

demand resulting in oxygen depletion. The DO level of the effluent was analyzed to be 3.12 mg/l. The DO level of the effluent satisfied FEPA's allowable limit while the water samples from both sections of the creek was analyzed to be potable as DO levels were below WHO limit.

BOD values of water samples from the upstream and downstream sections of the creek varied from 7.34 mg/l to 9.15 mg/l while the treated effluent had a BOD value of 15.62 mg/l. The increase of BOD value between the upstream and the downstream may be as a result of organic material contamination in water, accumulation of decomposable organic matter or high rate of sewage introduction beyond the assimilative capacity of the creek. Having satisfied the DPR limit of 125 mg/l, the effluent's BOD value was found to be higher than FEPA's allowable limit of 10 mg/l, hence, non-compliance. The BOD values of both sections of the water course do not satisfy the WHO limit of <4.0 mg/l, hence, renders it unsafe for consumption. Chemical Oxygen Demand (COD) is the amount of oxygen required for the oxidation of inorganic matter using a strong chemical oxidant. The higher the chemical oxygen demand, the higher the amount of pollution in the test sample. COD levels for the upstream and downstream sections of the creek were analyzed to be 12.85 mg/l and 14.78 mg/l respectively while that of the effluent was found to be 49.10 mg/l. From the table, the effluent's COD level showed to be below DPR limit of 125.0 mg/l but above FEPA limit of 40.0 mg/l. The higher level of COD in the effluent discharged indicate that it contains high oxygen demanding materials, which causes depletion of dissolved oxygen in water thereby limiting its use for other purposes such as irrigation and recreational purposes. The high BOD and COD levels in water samples indicated that the water was highly polluted. It may be attributed to the high demand on dissolved oxygen by the wastes discharged into the water bodies. The upstream and downstream water samples exhibited higher levels of COD with respect to WHO limit for potable water thereby making the water from the creek unfit and unsafe for drinking.
