Flow Characteristics of the Jamuna River: During the 1988 and 1998 Catastrophic Flood Events in Bangladesh

Abstract

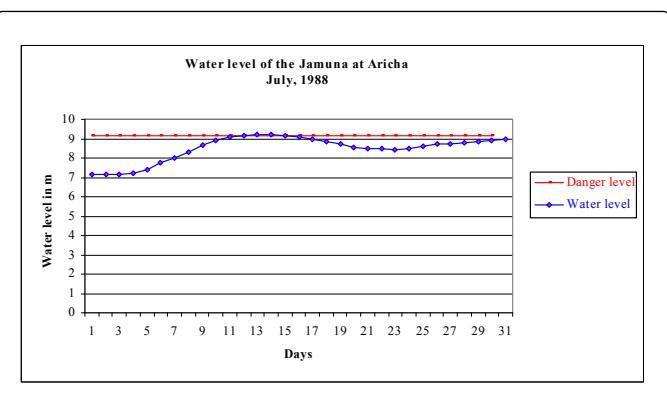
The Jamuna at Aricha station crossed the danger level on 13 July and was above the danger level for 3 days on 13, 14 and 15 July. The river rose up to 10.55 m on 31 August that was flowing 141 cm above the D.L. (9.14 m) on this date (Table 3). The Jamuna attained its peak at Aricha was 10.58 m (Table 1) on 2 September at 12:00 hrs, which was 144 cm above its danger level (BWDB, 2015). As a whole, the Jamuna at Aricha was above the danger level for 34 days in 1988 (July 3 days, August 16 days and September 15 days) which have been illustrated in Figures 3-5.

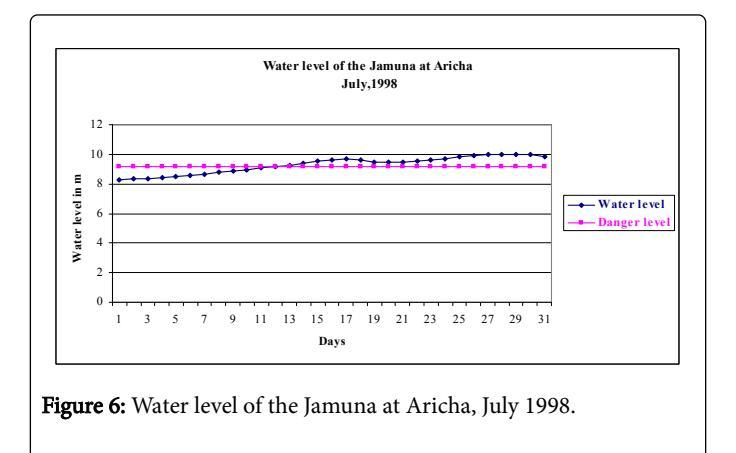
Figures (6-8) indicate that flood occurred from July 12 to September 18, with duration of 68 days (July 19 days, August 31 days and September 18 days). According to the IECO Report [25], the slope of the Brahmaputra from Bahadurabad to Goualanda is 0.35 ft/mile. The low gradient of the Jamuna is 0.25 ft/mile at this point influence the flow of excessive water from upper catchments area [26]. The synchronization of peak flows of the Ganges and the Brahmaputra-Jamuna rivers was the cause of severe flood at the study site. The 1998 flood submerged the district entirely, inundated about 67 percent area of the country, and turned into a prolonged one in the history of Bangladesh [12,21].
